KLUBER PROJECT NO. 26-508-1715

# E. Wilson Morrison Elementary School

**Structural Façade Assessment**  
**40 Crescent Street**  
**Front Royal, Virginia 22630**

■ August 31, 2026

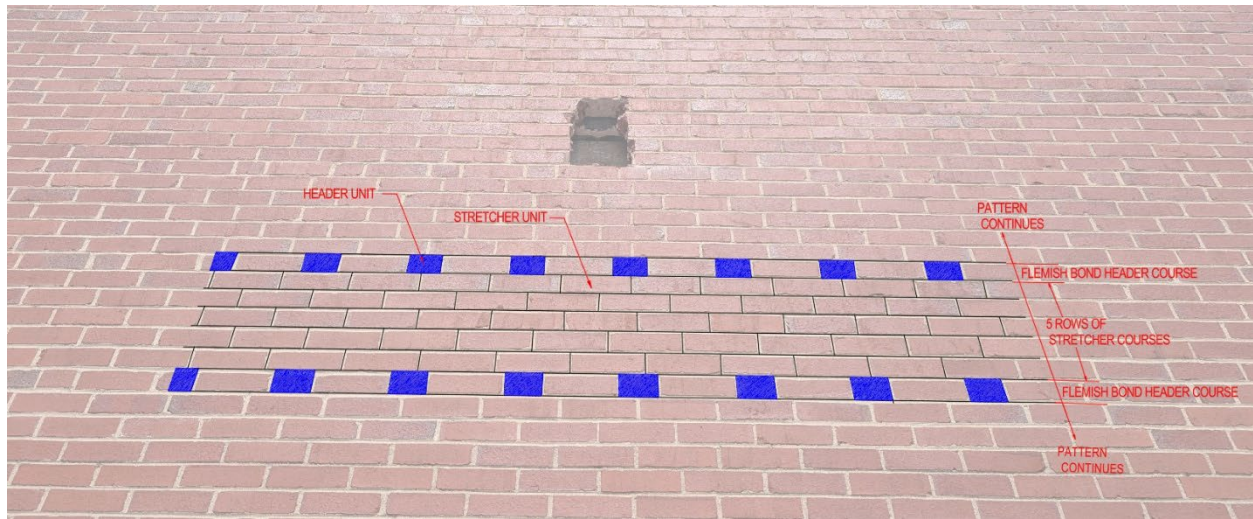
**Figure No. 003**  
**Façade Coursing Layout**

*Original 1935 and 1950 buildings appear to utilize this façade layout, but with a “mass-wall” construction type as shown in **Figure No. 002** - 3 wythe construction. The post 1945 construction replicates this design architecturally as seen above. Rather than the header courses tying directly into the masonry construction beyond with a full unit turned 90 degrees, these units have been cut, and metal ties have been provided for lateral stability to the cinder block construction beyond, typical for cavity wall construction.*

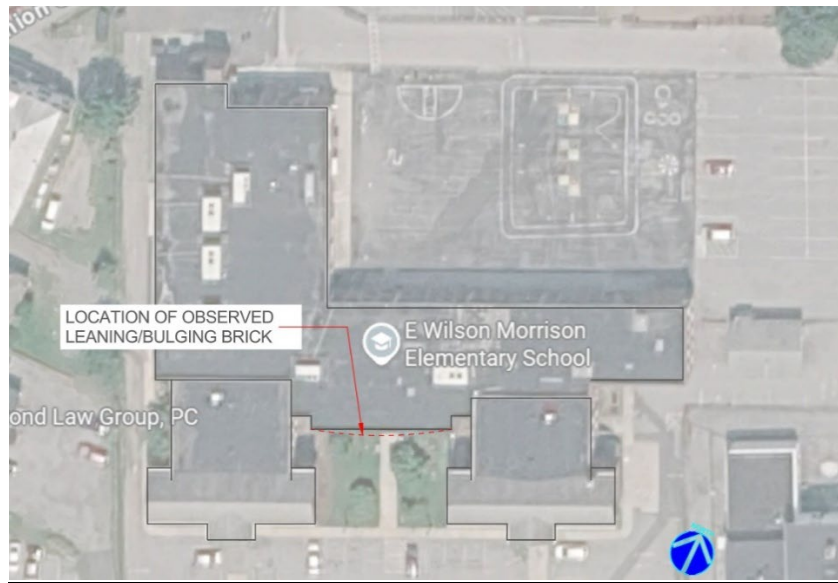
**Figure No. 004**  
**Localized area of bulging facade**

The movement of masonry façade at the school was first observed at the main southern entrance identified in **Figure No. 004** (below). As observed in **Photos No. 003 – 005 & 12**, the masonry veneer wall has visibly displaced away from the structure approximately 2 to 3 inches near the second-floor line. In observing the opened areas, the wall construction for the connecting additions is clearly a “cavity-wall” construction in lieu of “mass-masonry”, reference **Photos No. 013 – 018 & Photo No. 034**. We were unable to locate any drainage weeps for the cavity construction, which is critical for the long-term performance of cavity-wall construction. Refer to **Photos No. 002 – 020**, **No. 032 – 041 & No. 051** for observations made at the south façade of the post 1945 construction. Also reference **Photos No. 022 – 031** for observations made of the roof area along the southern façade wall. Our office completed a walk-around the entire site and determined that the bulging and pulling away of masonry façade was also evident along the northern and eastern facades of the post 1945 construction. Refer to **Photos No. 042 – 048** for the northern façade observations and **Photos No. 049 & 050** for the eastern façade.

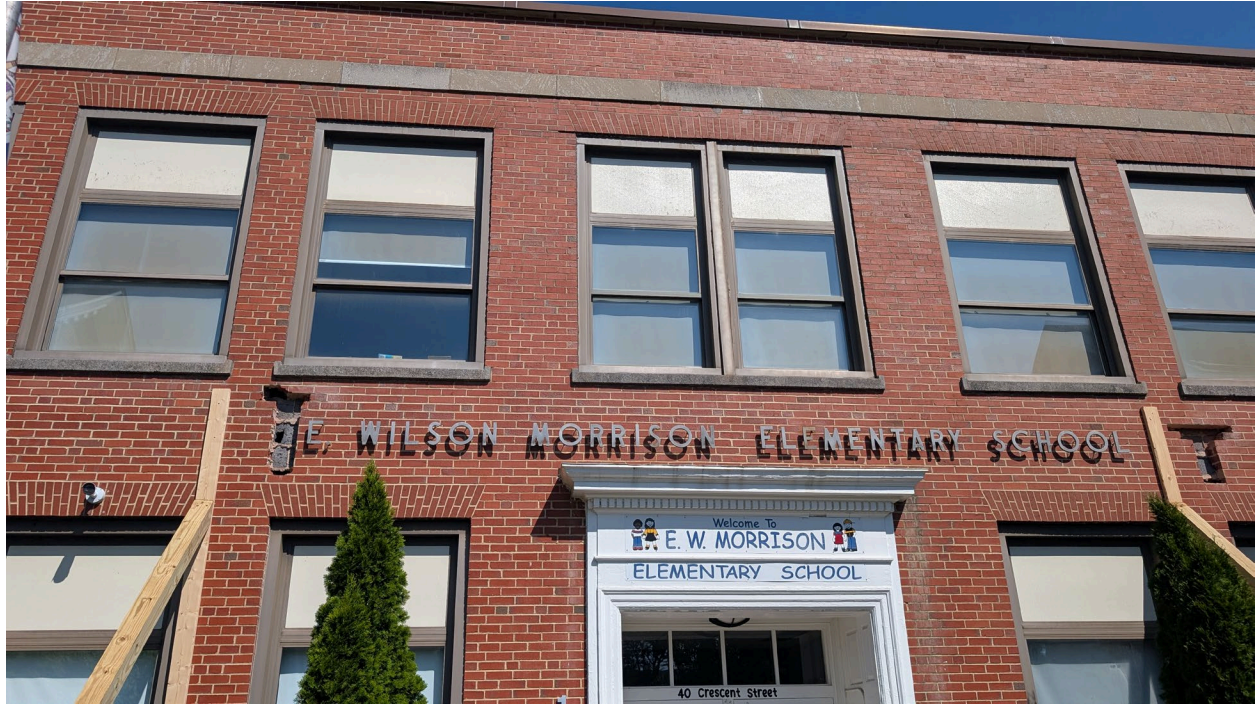
**NUMBER:** 002

**COMMENTS:**  
South elevation view of main entrance.

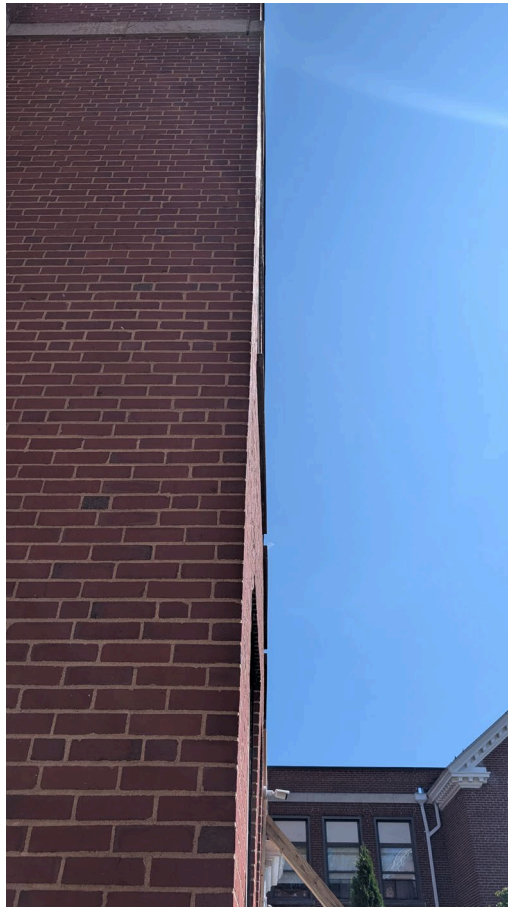
**NUMBER:** 003

West elevation view showing masonry brick veneer pulling away from structure.

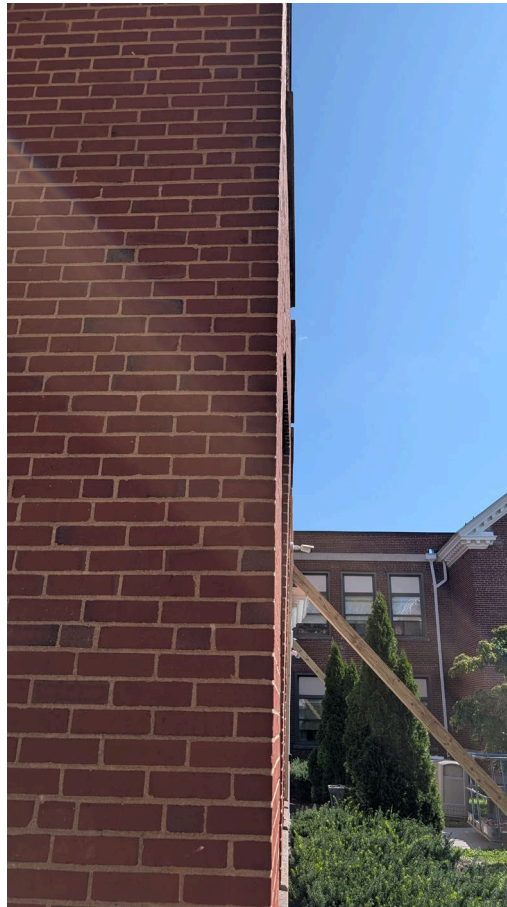
**NUMBER:** 004

West elevation view showing masonry brick veneer pulling away from structure. Temporary means of support to prevent facade from further movement has been installed.

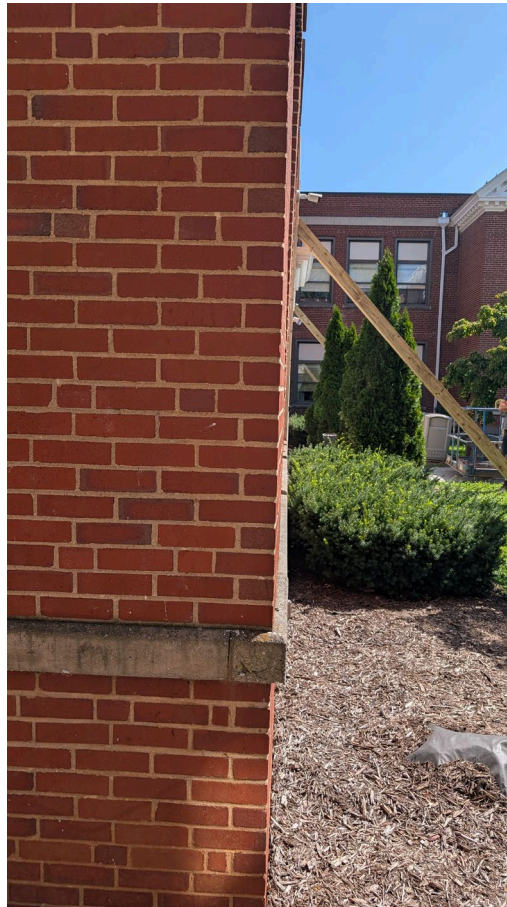
**NUMBER:** 005

West elevation view showing masonry brick veneer pulling away from structure. Temporary means of support to prevent facade from further movement has been installed.

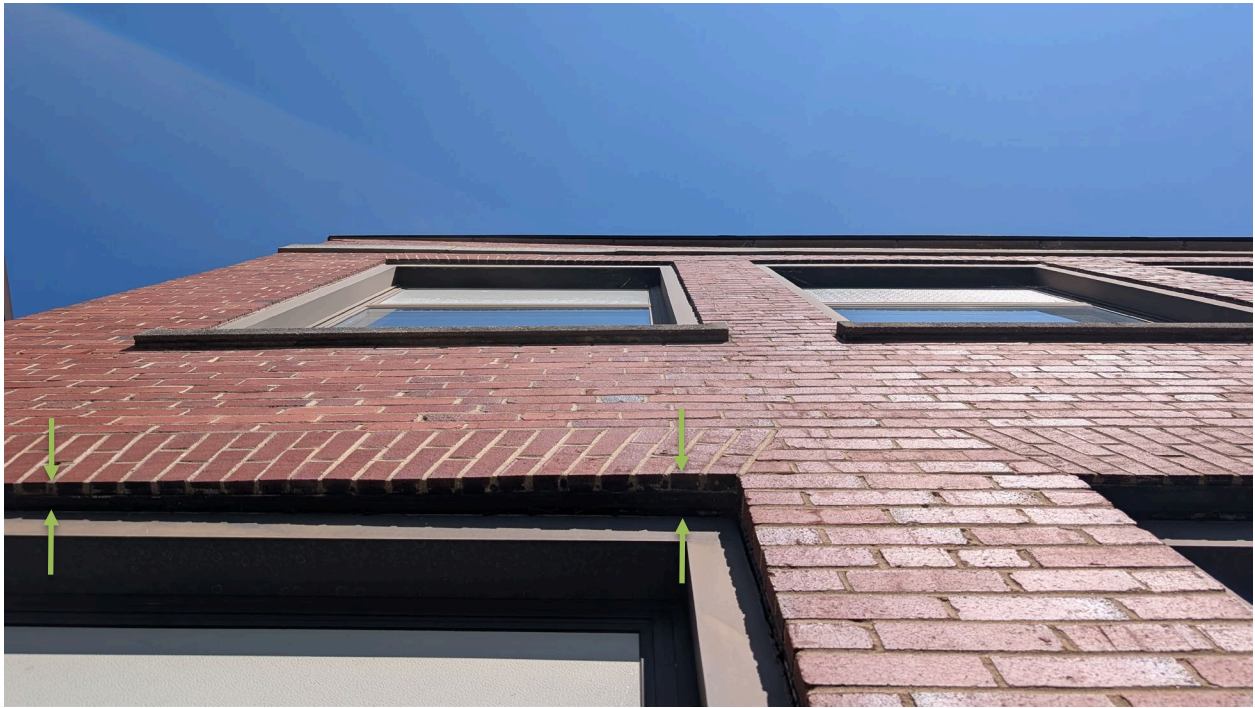
**NUMBER:** 006

View looking up the southern face of building where façade is pulling away. Visible movement can be seen at window frame where the sealant joint has separated.

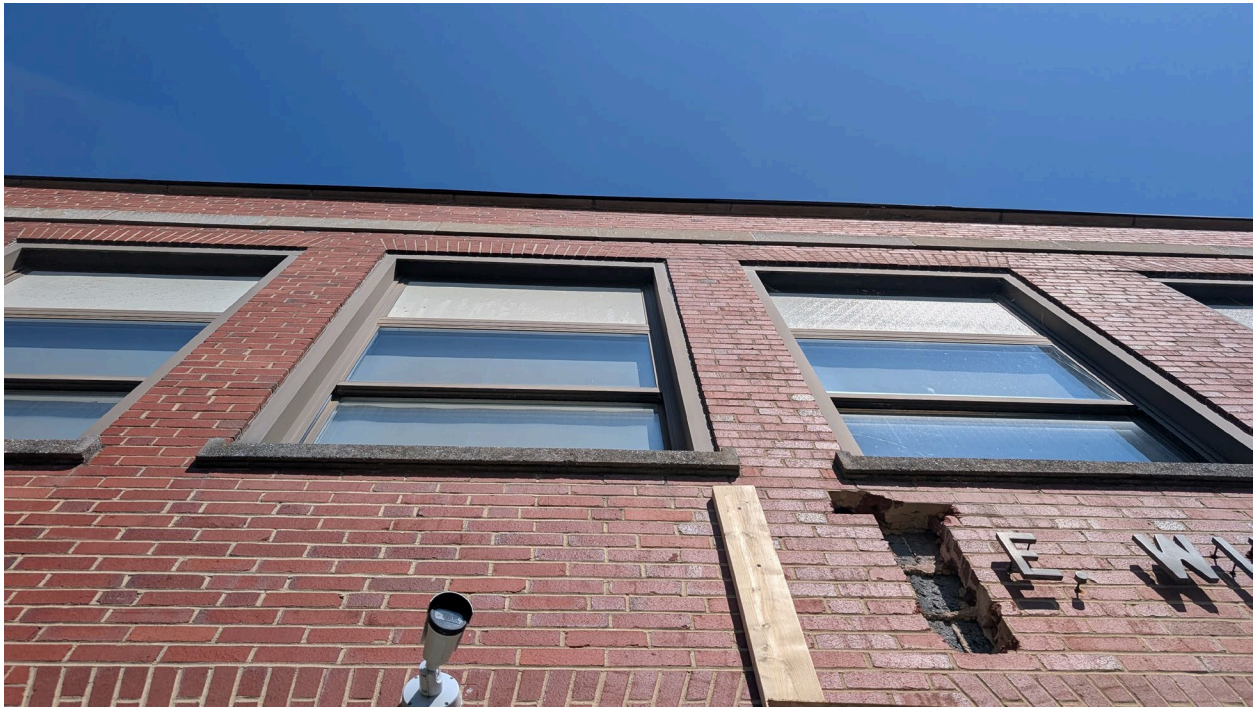
**NUMBER:** 007

View looking up the southern face of building where façade is pulling away. Portal holes have been opened exposing the cavity wall construction and the cinder block masonry load bearing wall.

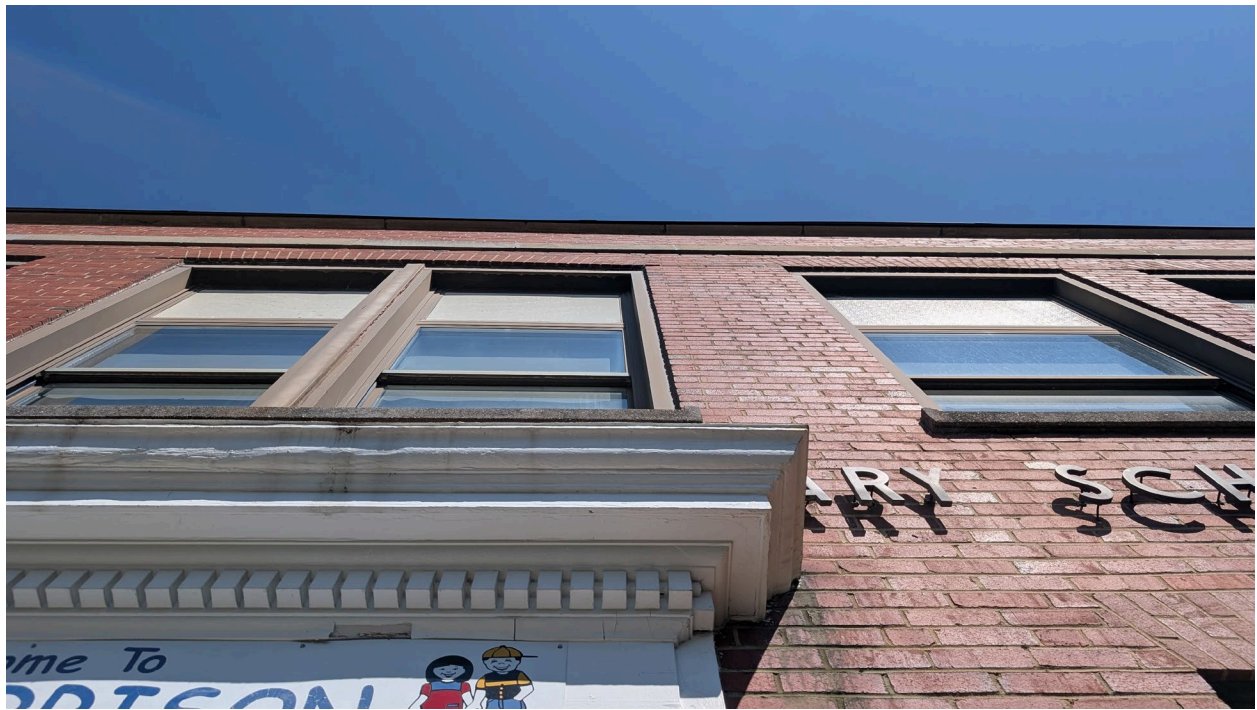
**NUMBER:** 008

View looking up the southern face of building where façade is pulling away, just right of main entrance.

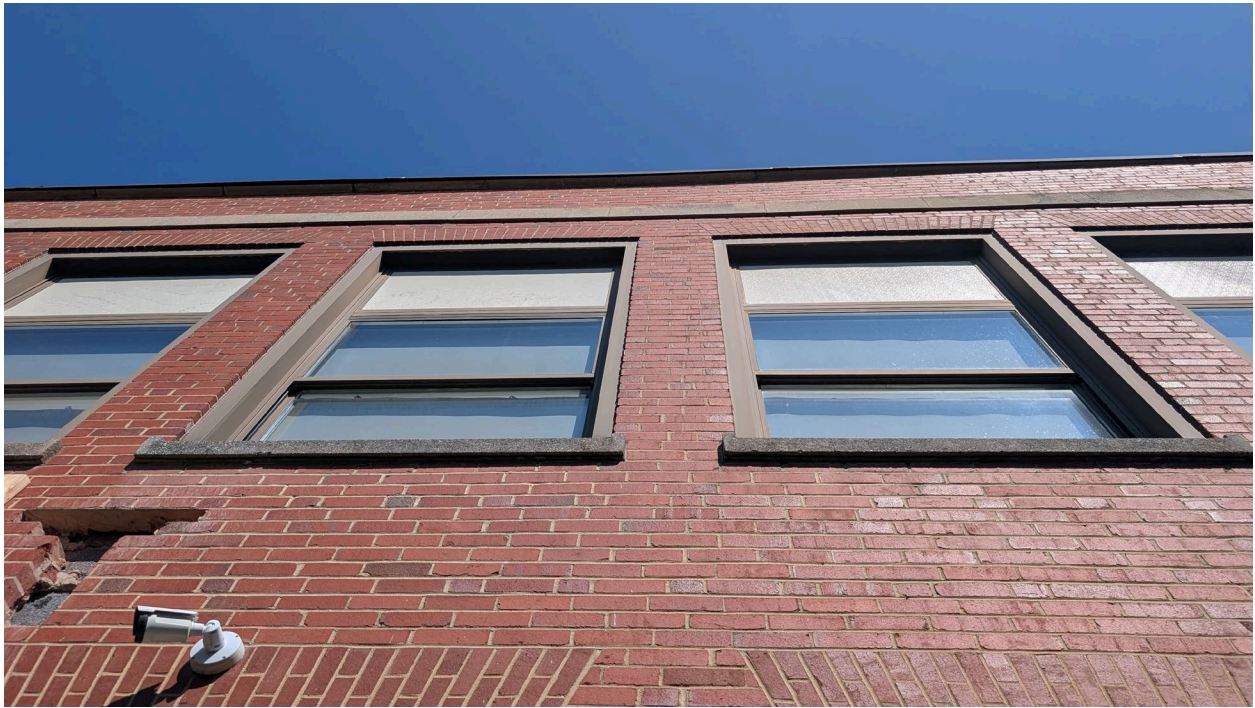
**NUMBER:** 009

View looking up the southern face of building where façade is pulling away, just right of main entrance. Portal holes have been opened exposing the cavity wall construction and cinder block masonry load bearing wall.

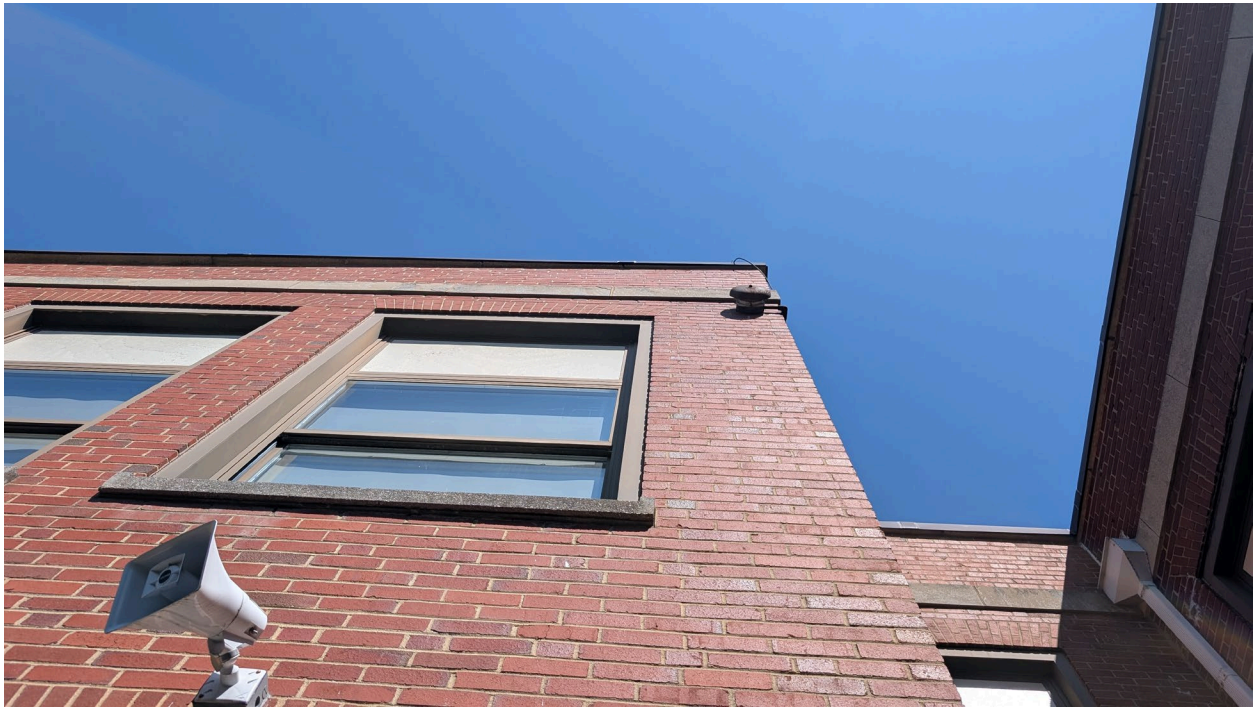
**NUMBER:** 010

View looking up the southern face of building where façade is pulling away, east end.

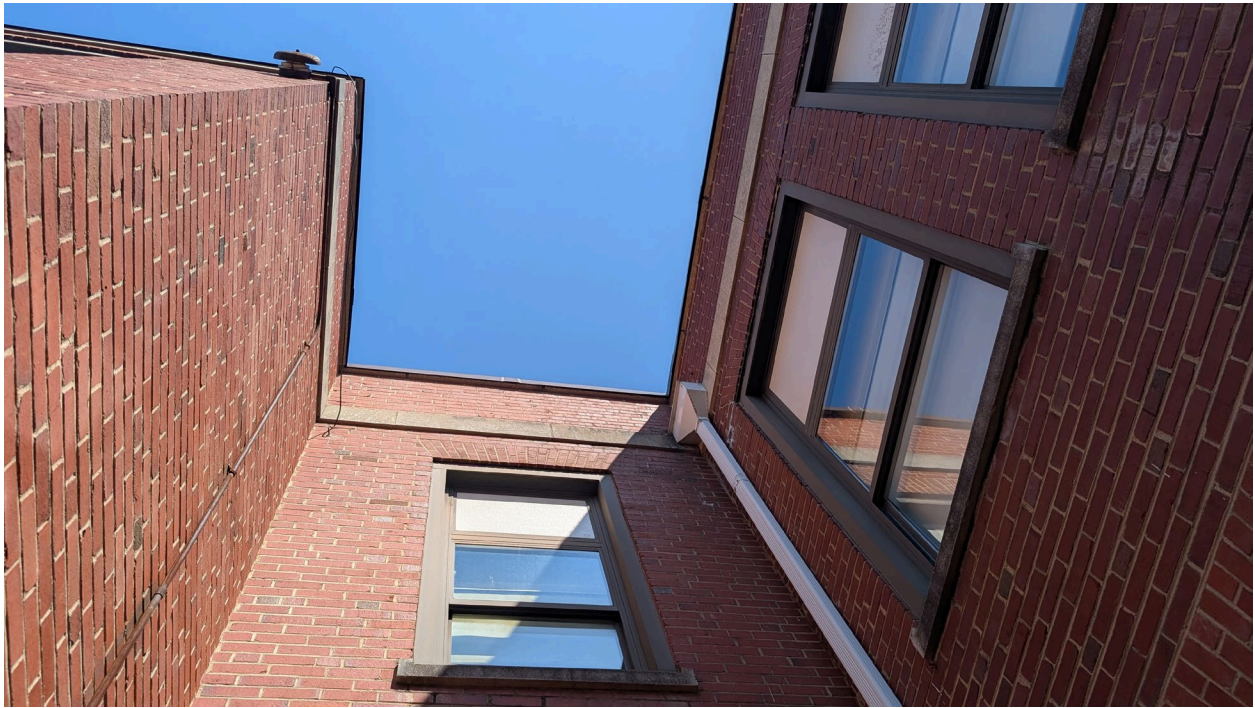
**NUMBER:** 011

View looking up the southern face of building “notch” east of main entrance. Movement of façade here not apparent.

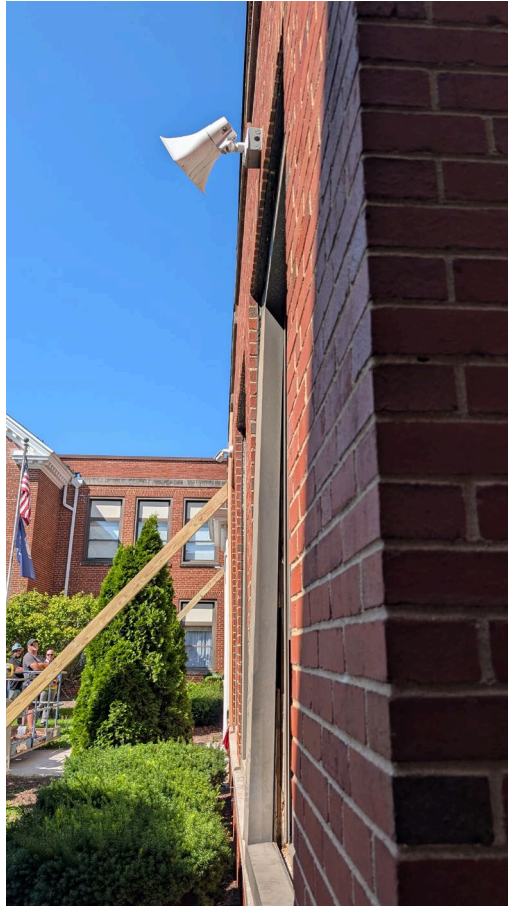
**NUMBER:** 012

East elevation looking along face of south main entrance where façade is pulling away. Gaps and movement clearly visible at window frames & stone sills.

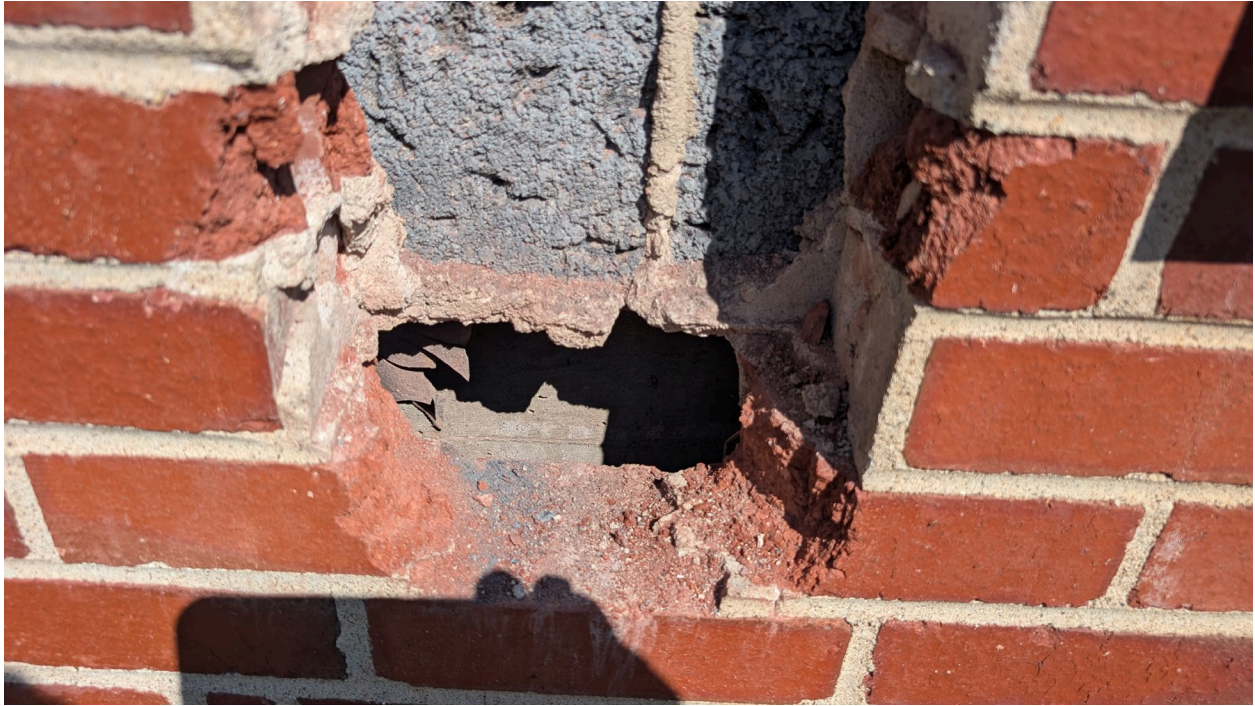
**NUMBER:** 013

Based on review of the site investigation, photographs and existing construction documentation, we conclude that the façade instability is related to the construction of the masonry cavity wall and its inability to drain effectively. Cavity space within the construction observed was minimal and essentially clogged up with excess mortar. With the inability for the construction of the airspace to effectively stay dry, is what has led to the failure of metal tie-back supports. Apart from the façade movements observed and discussed, we believe that the concrete superstructure and roof framing appeared in good working condition.

Portal hole in facade south wall, west end. Cinder block structural wall and brick façade veneer clearly seen indicating a cavity wall type construction. Air-space between wythes appears minimal to none and filled with mortar.

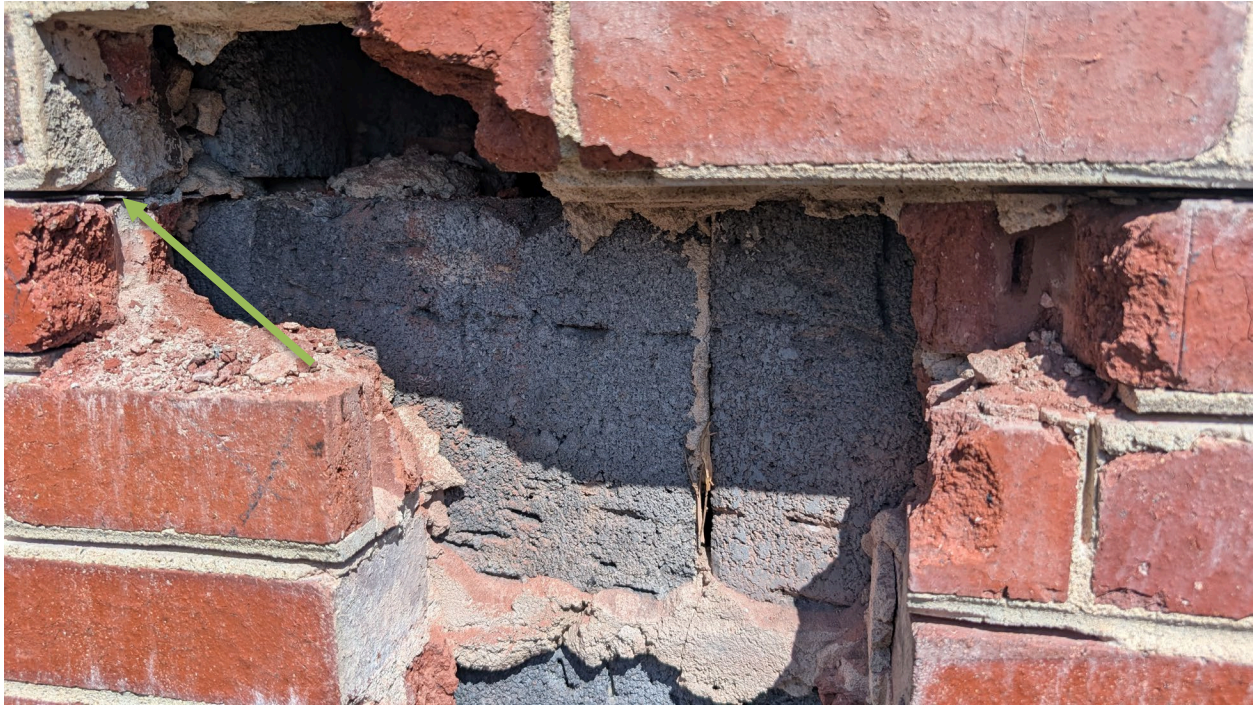
**NUMBER:** 014

Portal hole in facades south wall. Cinder block structural wall and brick façade veneer clearly seen indicating a cavity wall type construction. Air-space between wythes appears minimal to none and filled with mortar. Green arrow pointing at corrugated veneer tie for anchoring the brick veneer to the cinder block load bearing wall.

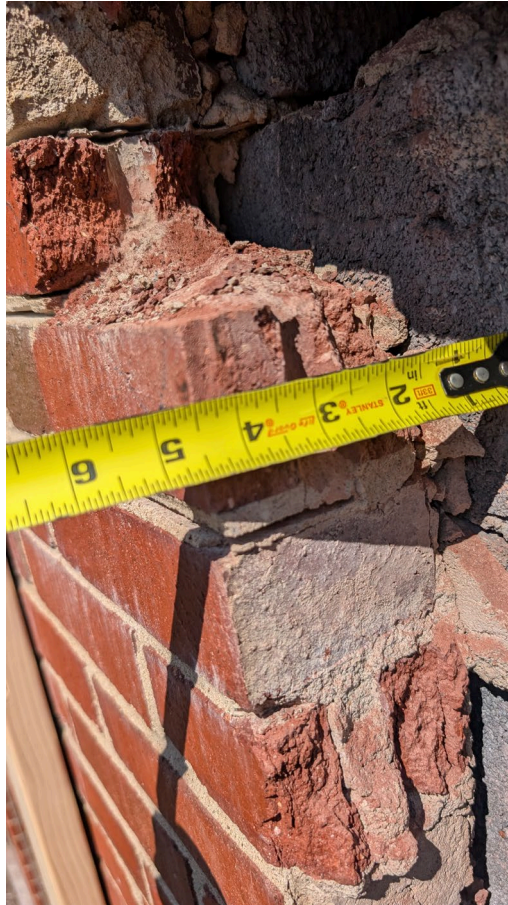
**NUMBER:** 015

Measurement (+/- 4½") of cavity wall construction from façade face back to structural cinder block.

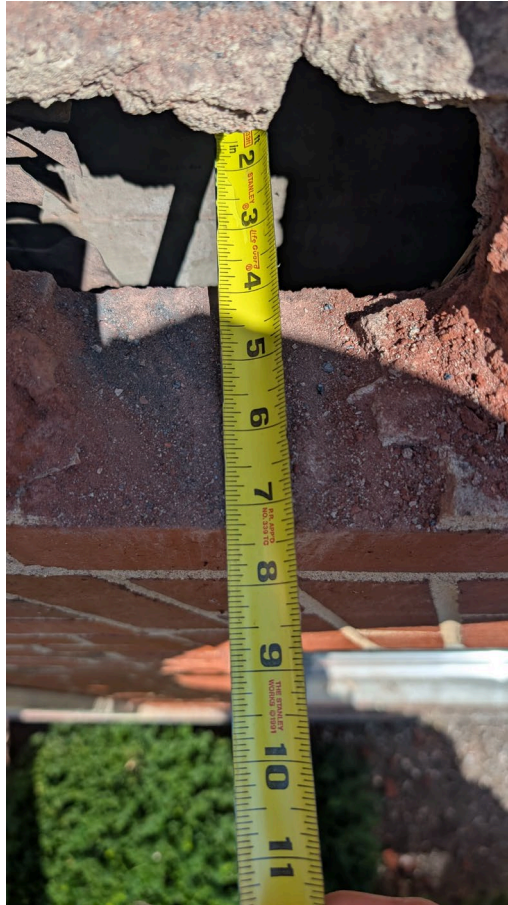
**NUMBER:** 016

Measurement (+/-8") of cavity wall construction from the exterior face of the brick veneer to the face of the structural concrete floor slab.

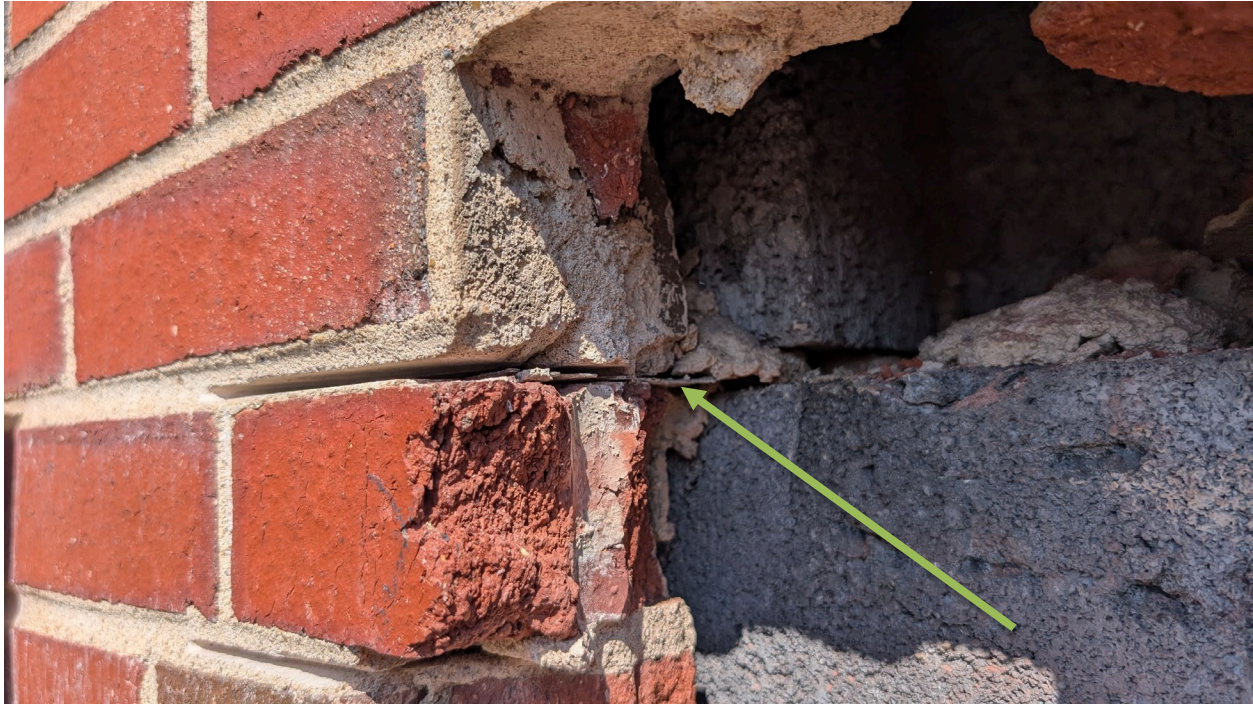
**NUMBER:** 017

Portal hole in facades south wall. Cinder block structural wall and brick façade veneer clearly seen indicating a cavity wall type construction. Air-space between wythes appears minimal to none and filled with mortar. Green arrow pointing at corrugated veneer tie for anchoring the brick veneer to the cinder block load bearing wall.

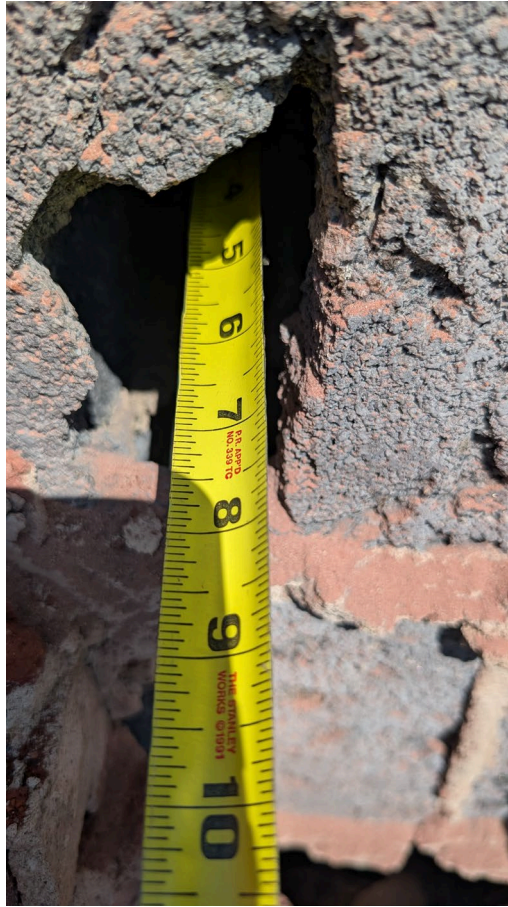
**NUMBER:** 018

Measurement of the cinder block load bearing wall measured to be a nominal 8".

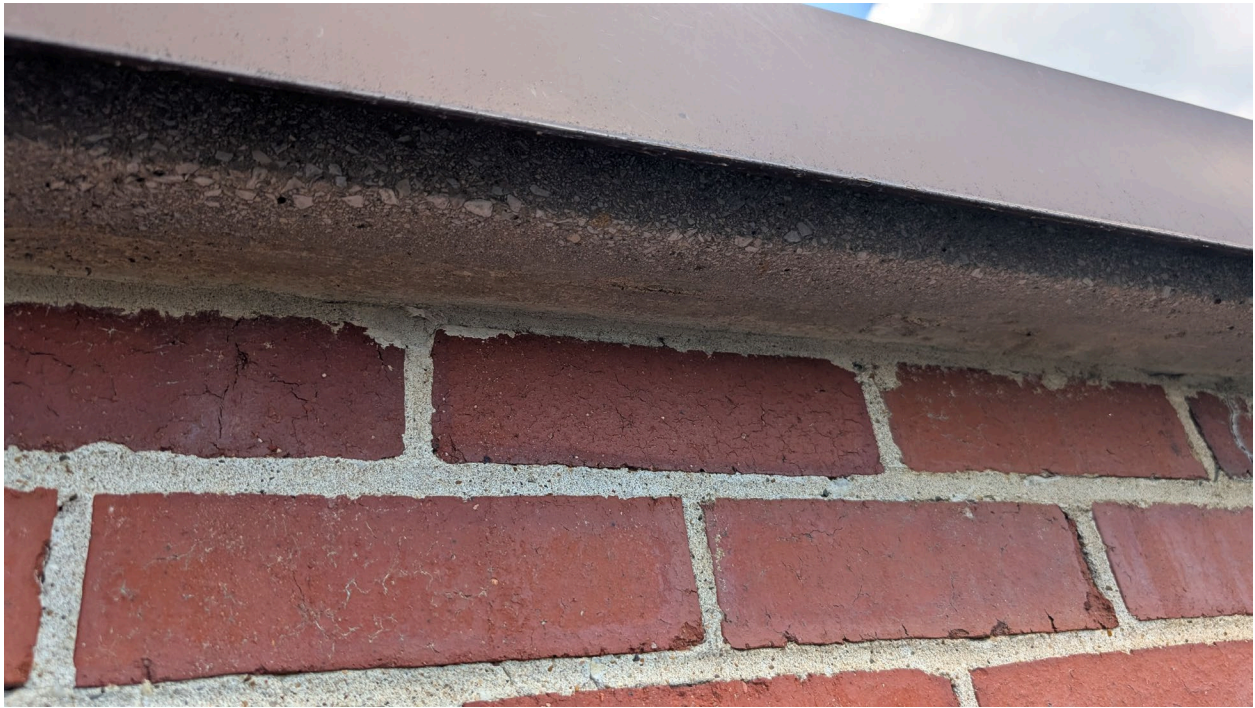
**NUMBER:** 019

Underside view of cast concrete parapet cap. Cap has since been wrapped with metal coping likely during re-roofing of the structure.

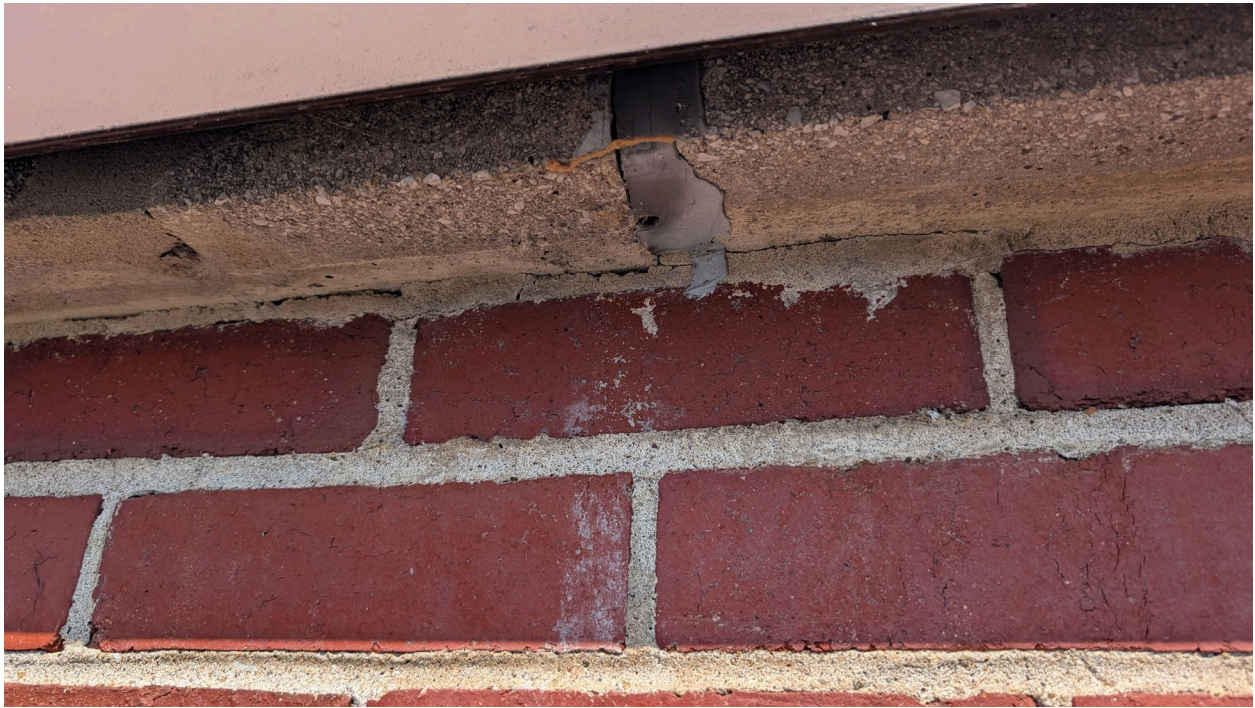
**NUMBER:** 020

Underside view of cast concrete parapet cap. Cap has since been wrapped with metal coping likely during re-roofing of the structure.

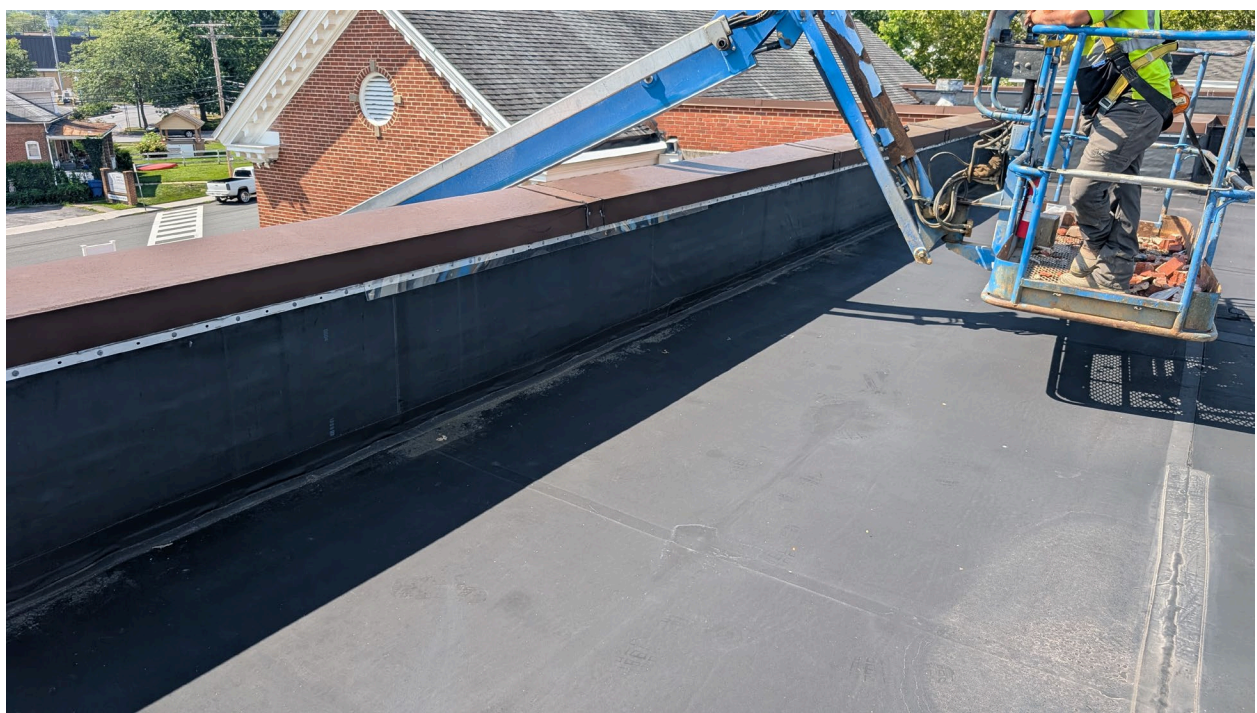
**NUMBER:** 021

Backside of parapet wall viewed from roof surface. Coping with flashing up backside of parapet wall appeared in good working condition.

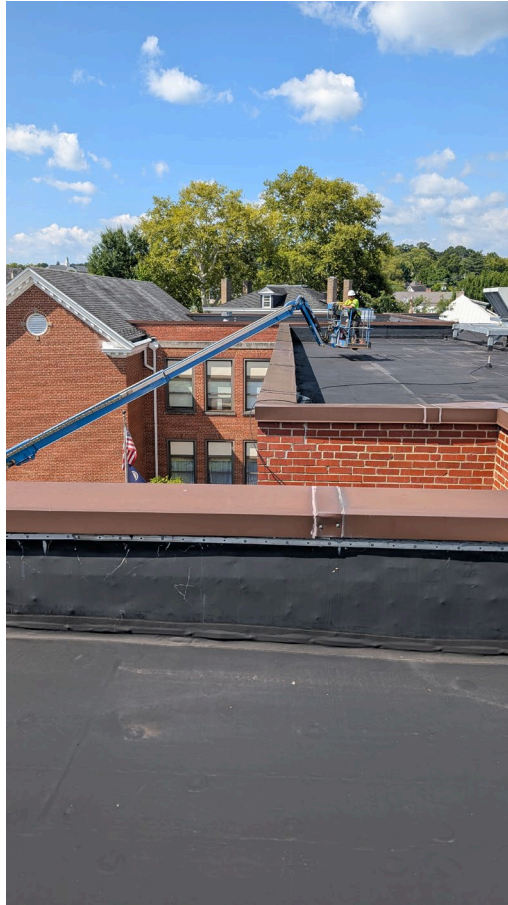
**NUMBER:** 022

East view of parapet wall along its length. Parapet at roof line appeared relatively straight. Main bulging / pulling-away in façade appear to be concentrated at the second-floor line of the structure.

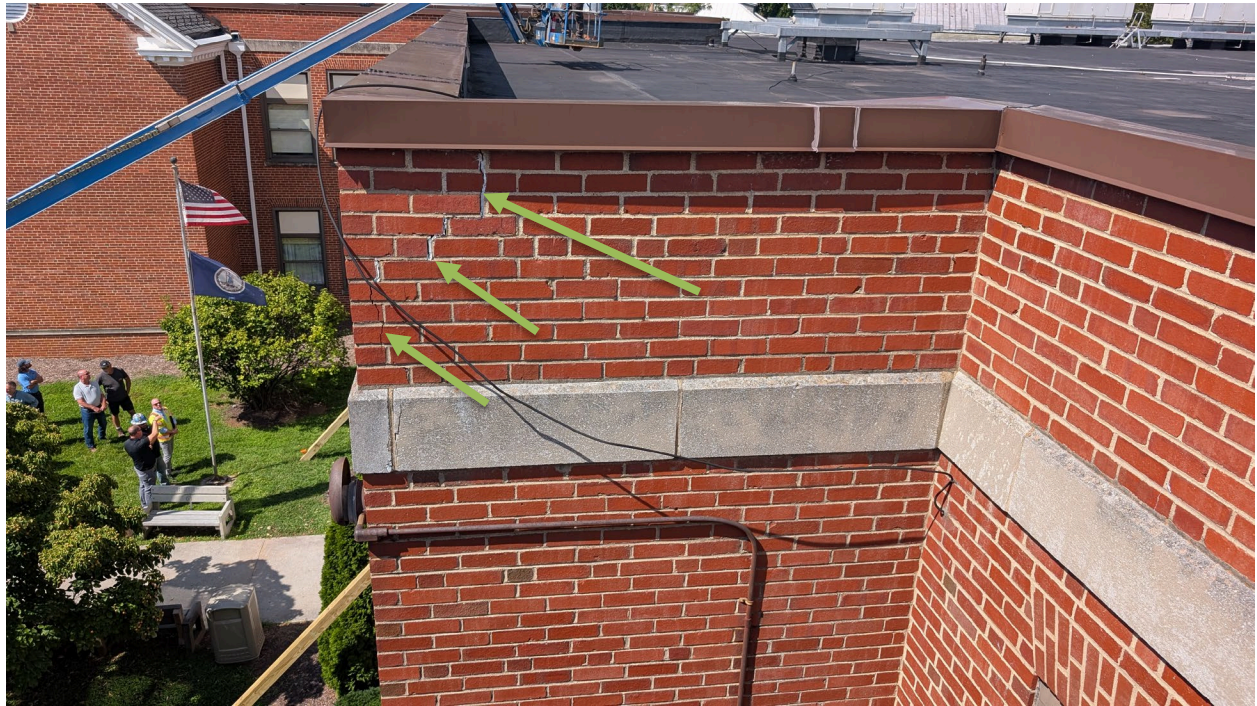
**NUMBER:** 023

View of parapet wall façade near southeast corner. Step cracking and joint separation observed likely due to facades movement away from structure (green arrows).

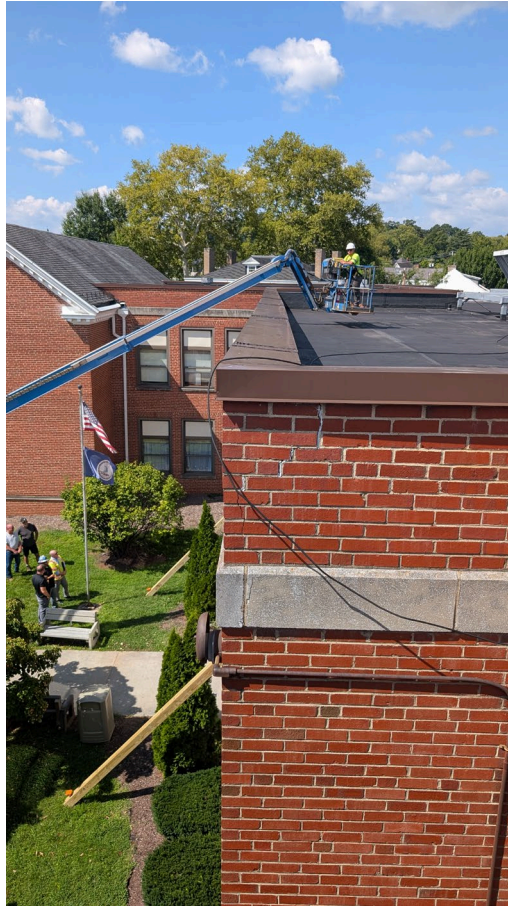
**NUMBER:** 024

View of parapet wall façade near southeast corner. Step cracking and joint separation observed likely due to facades movement away from structure (see green arrows on **Photo 023**).

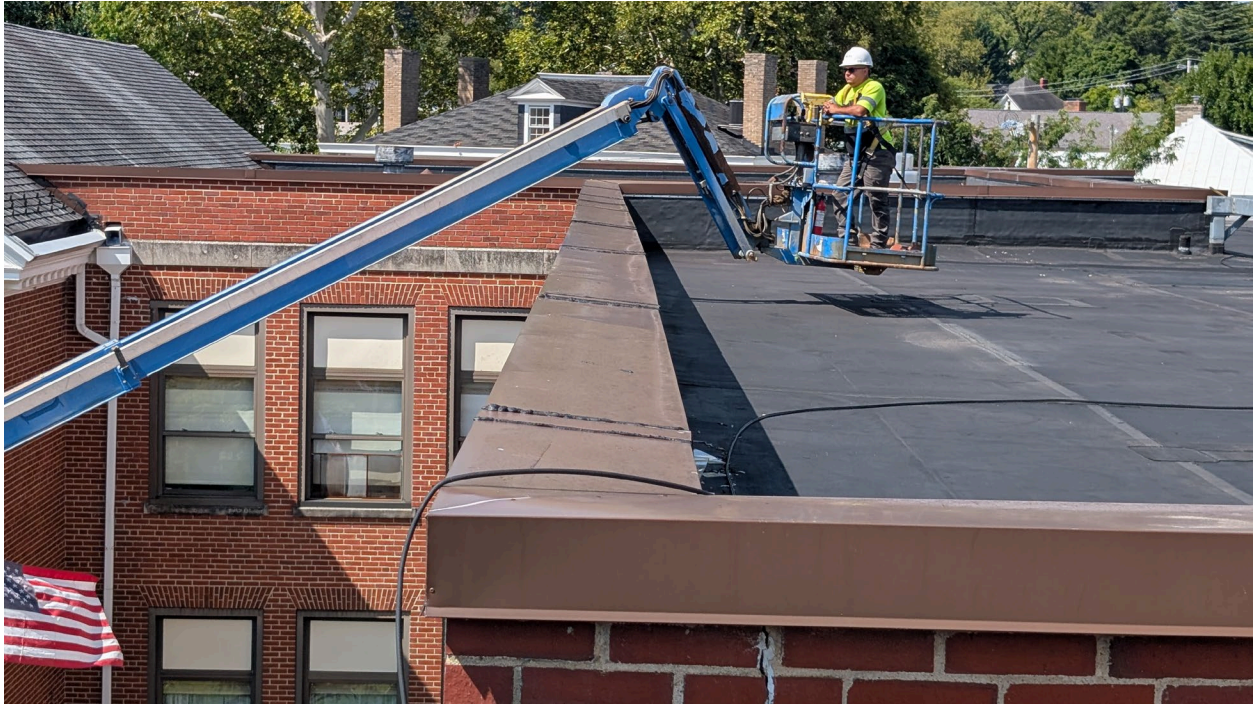
**NUMBER:** 025

East view of parapet wall along its length. Parapet at roof line appeared relatively straight. Main bulging / pulling-away in façade appear to be concentrated at the second-floor line of the structure.

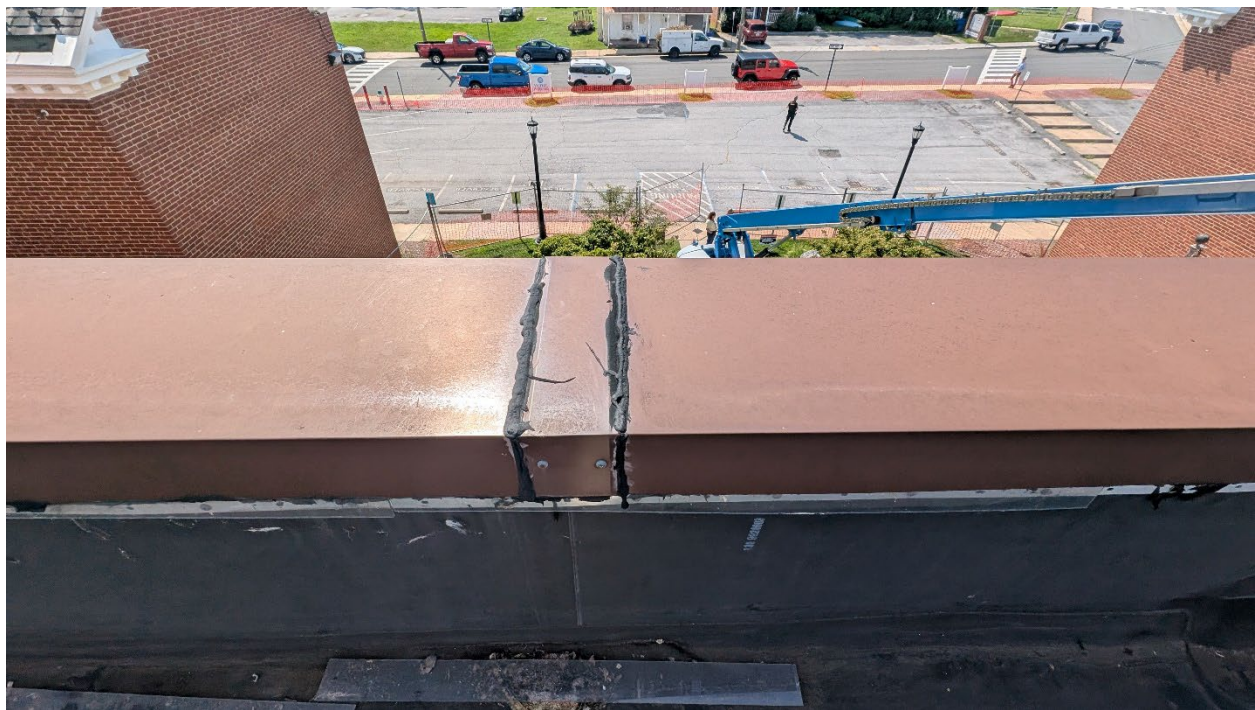
**NUMBER:** 026

Sealant of coping joints observed over south wall parapet. No visible distress observed.

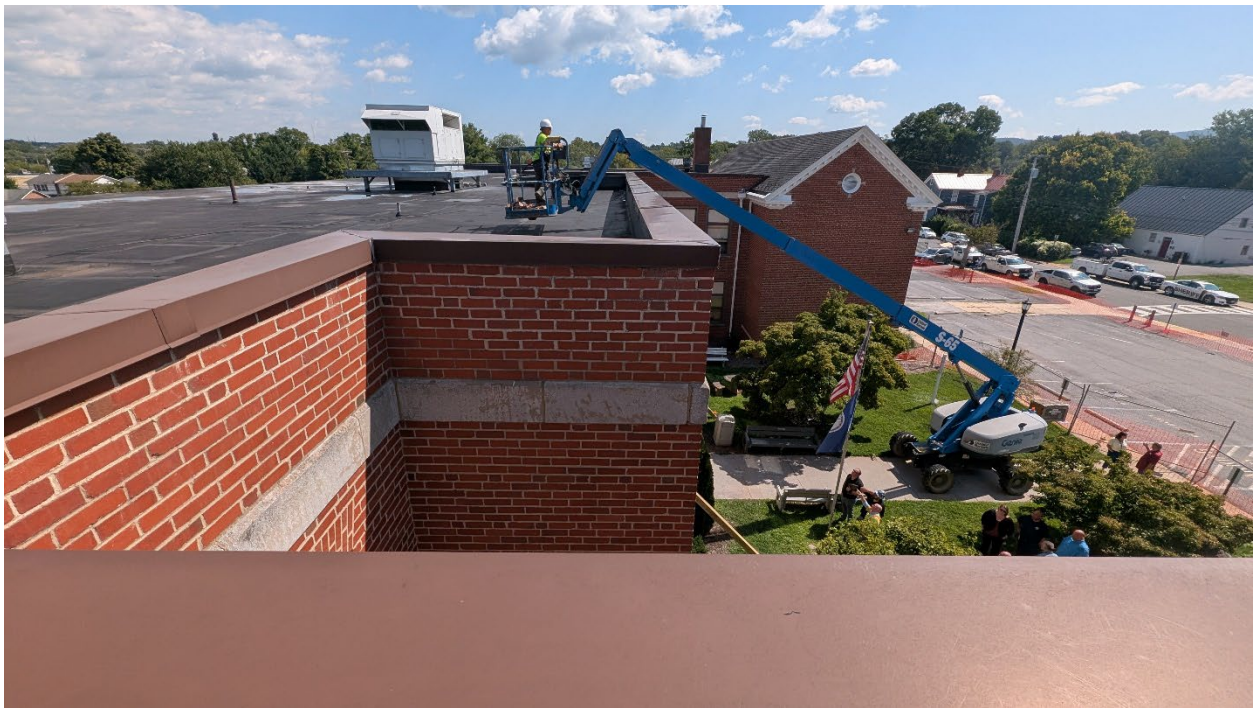
**NUMBER:** 027

West view of parapet wall along its length. Parapet at roof line appeared relatively straight. Main bulging / pulling-away of façade appear to be concentrated at the second-floor line of the structure.

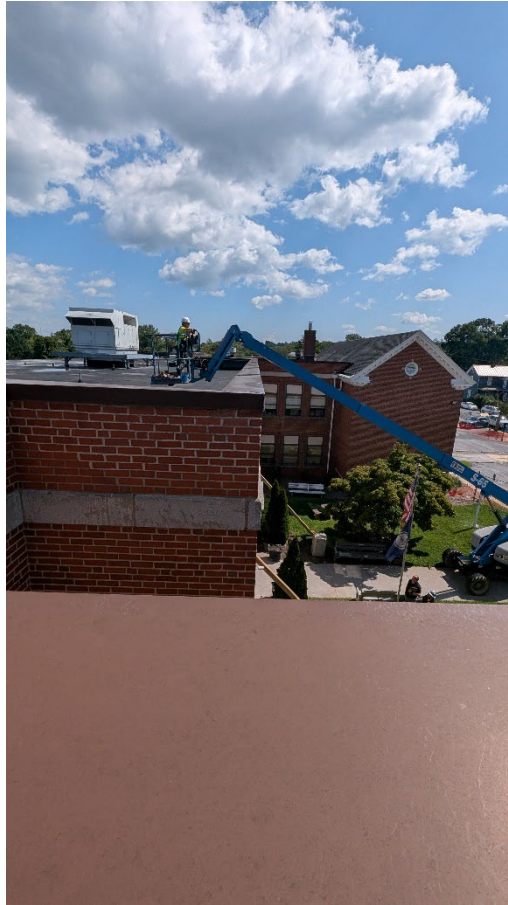
**NUMBER:** 028

West view of parapet wall along its length. Parapet at roof line appeared relatively straight. Main bulging / pulling-away of façade appear to be concentrated at the second-floor line of the structure.
