KLUBER PROJECT NO. 26-508-1715

# E. Wilson Morrison Elementary School

**Structural Façade Assessment**  
**40 Crescent Street**  
**Front Royal, Virginia 22630**

■ August 31, 2026

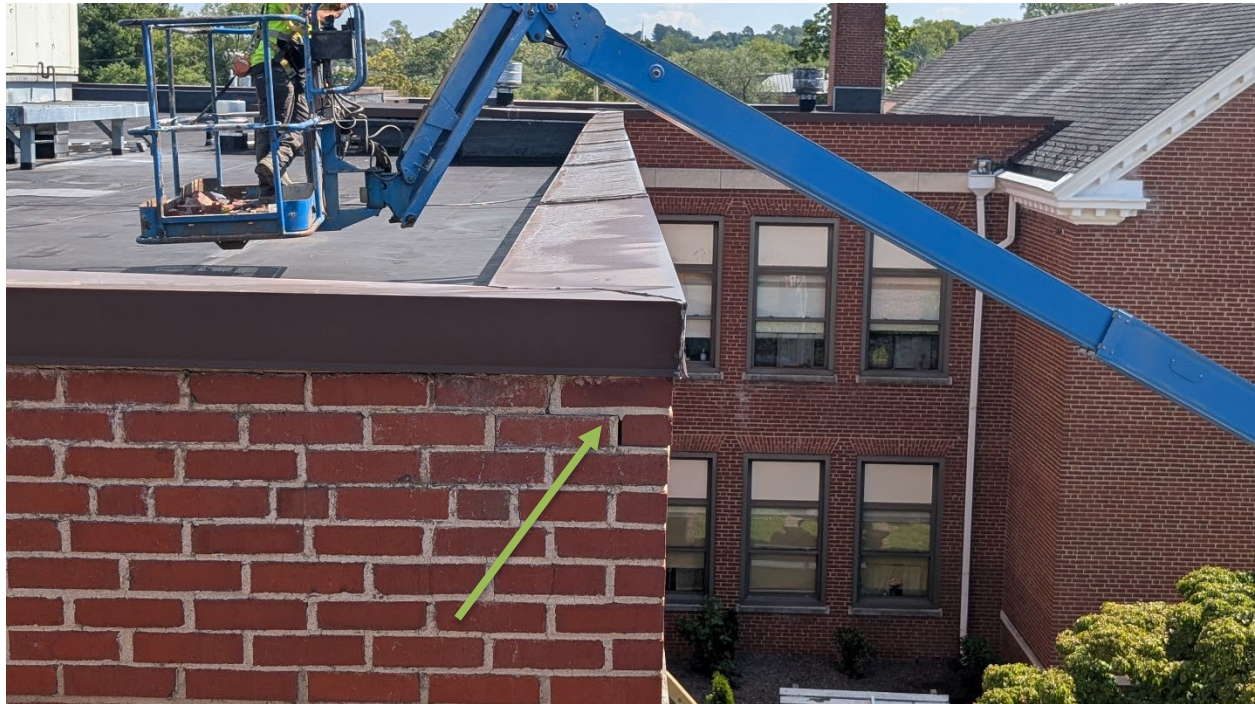
**NUMBER:** 029

West view of parapet wall facade. Mortar joints along parapet appear thicker/ lighter in color indicating this area may have been recently tuckpointed. Separation in corner head joint indicates movements likely occurred post-tuckpointing attempts (see green arrow).

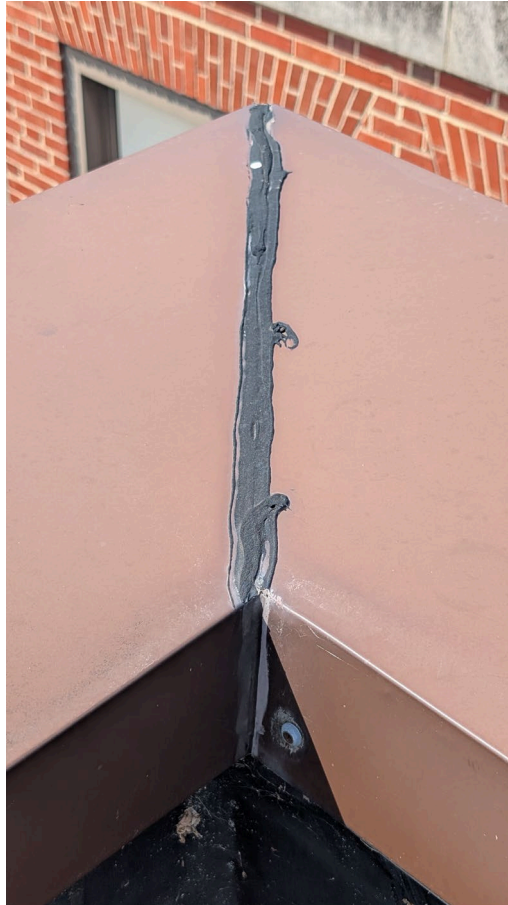
**NUMBER:** 030

Parapet coping sealant at southwest corner. No visible distress observed.

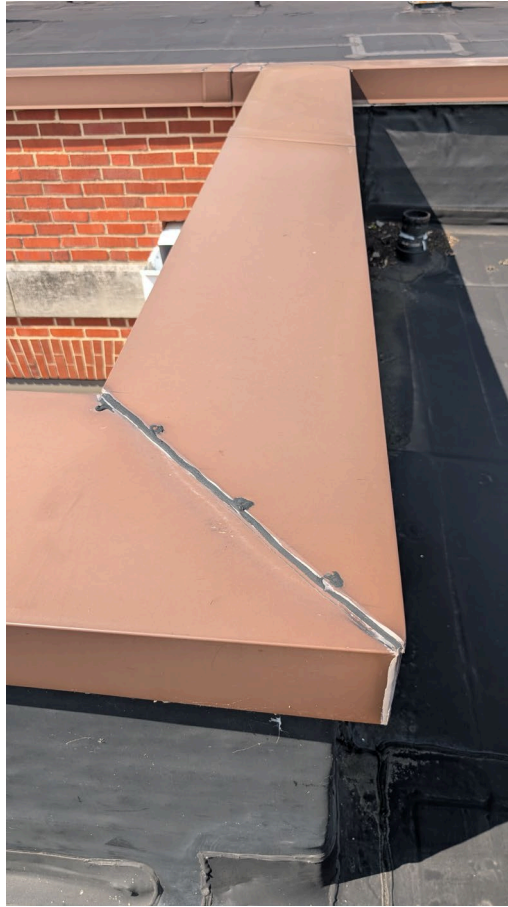
**NUMBER:** 031

Parapet coping sealant at northwest corner. No visible distress observed.

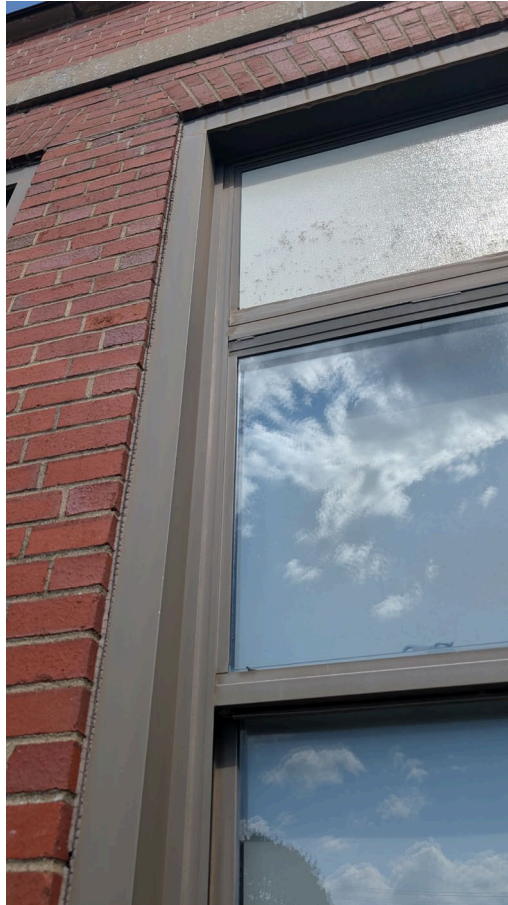
**NUMBER:** 032

View of window frame along south main entrance façade – south end. Vertical sealant at frame appears dried out and has failed showing separation. This can allow water to enter the cavity wall causing deterioration to the metal tie-backs.

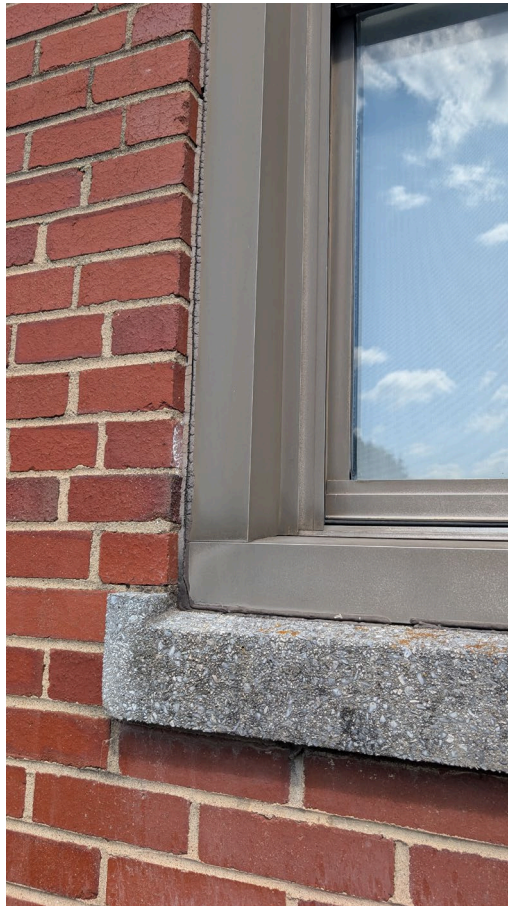
**NUMBER:** 033

View of window frame along south main entrance façade – south end. Vertical and horizontal sealants around window frame appear dried out and has failed showing separation. This can allow water to enter the cavity wall causing deterioration to the metal tie-backs.

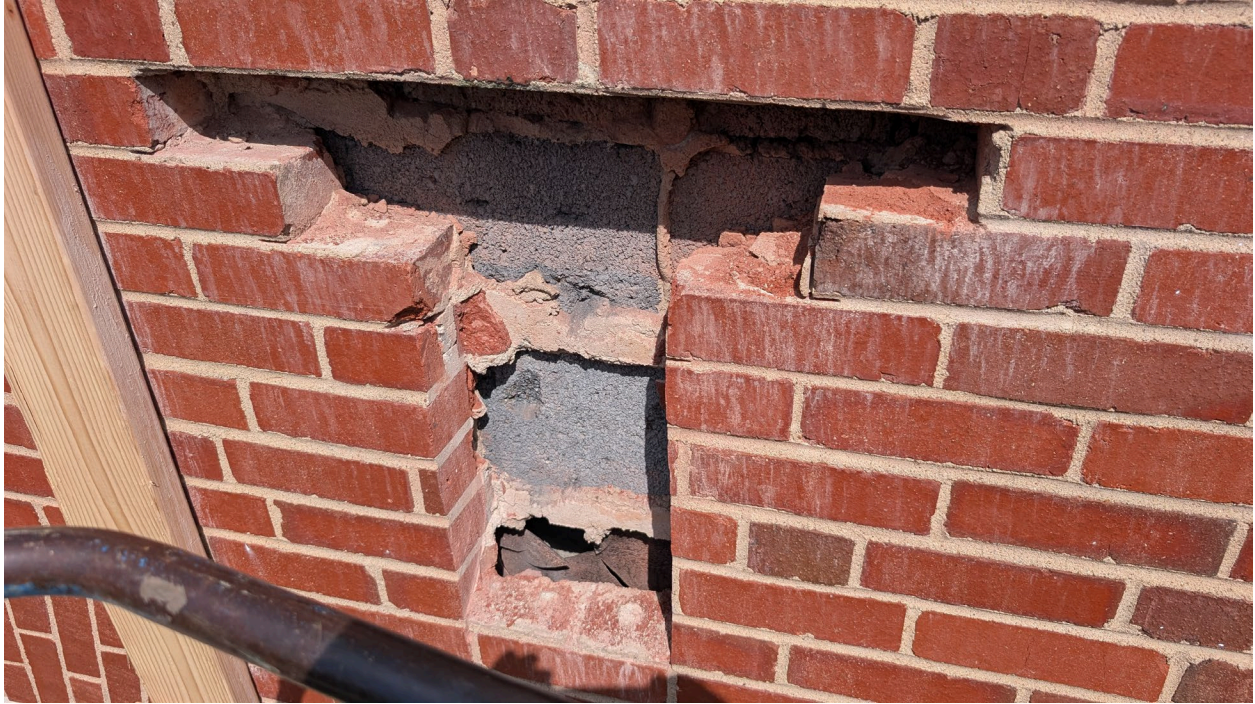
**NUMBER:** 034

Portal hole in facades south wall. CMU structural wall and brick façade veneer clearly seen indicating a cavity wall type construction. Air-space between wythes appears minimal to none and filled with mortar.

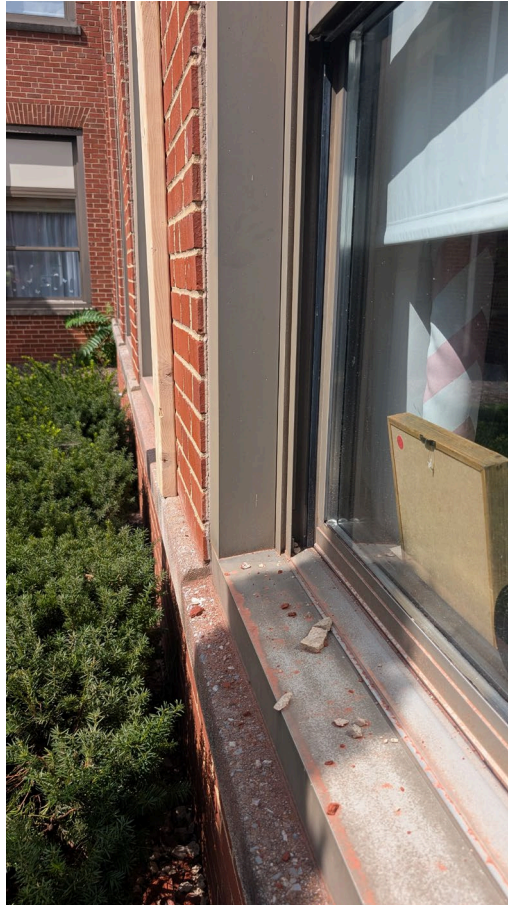
**NUMBER:** 035

South façade has noticeable outward displacement relative to window frame.

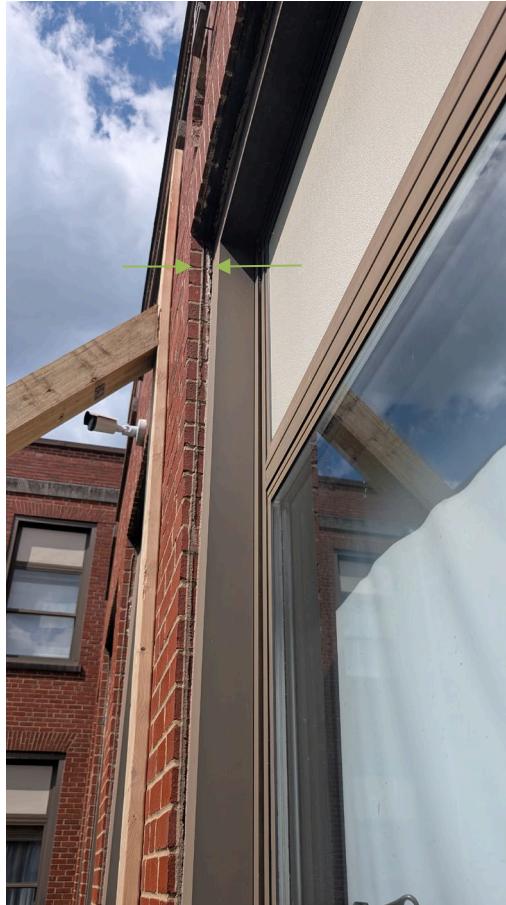
**NUMBER:** 036

South façade has noticeable outward displacement relative to window frame.
