**LOCATION:** E. Wilson Morrison Elementary School

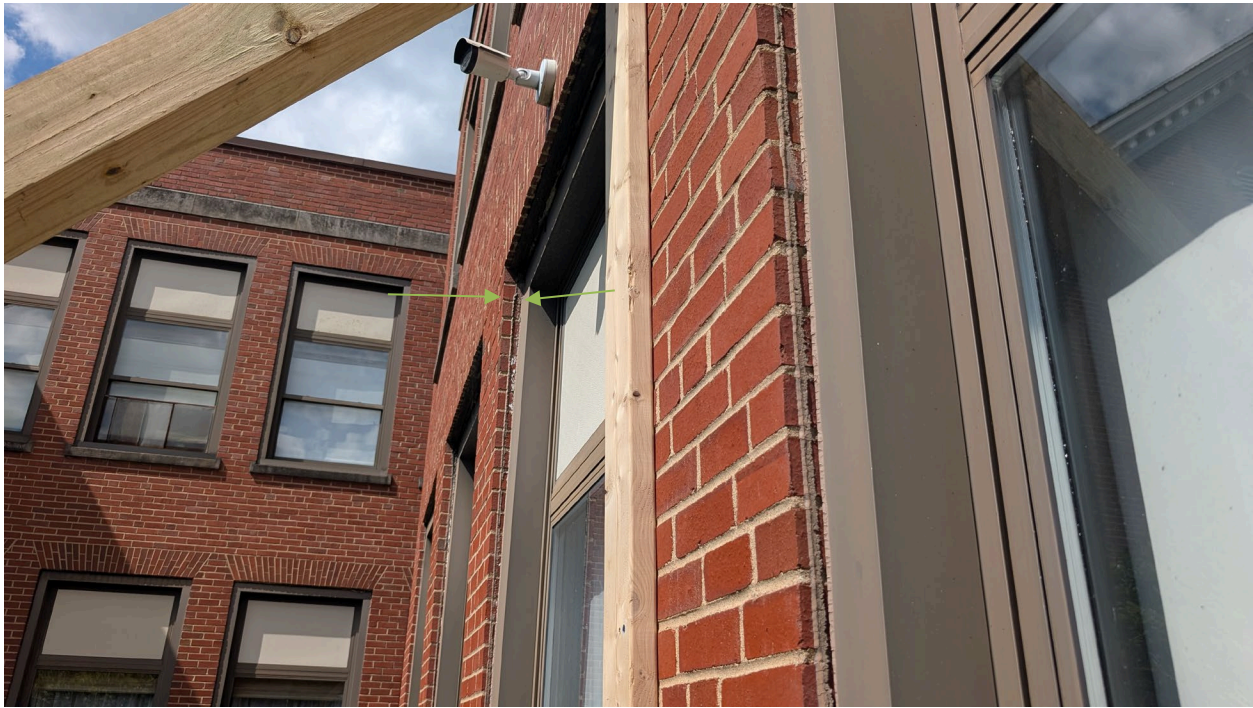
**NUMBER:** 037

South façade has noticeable outward displacement relative to window frame.

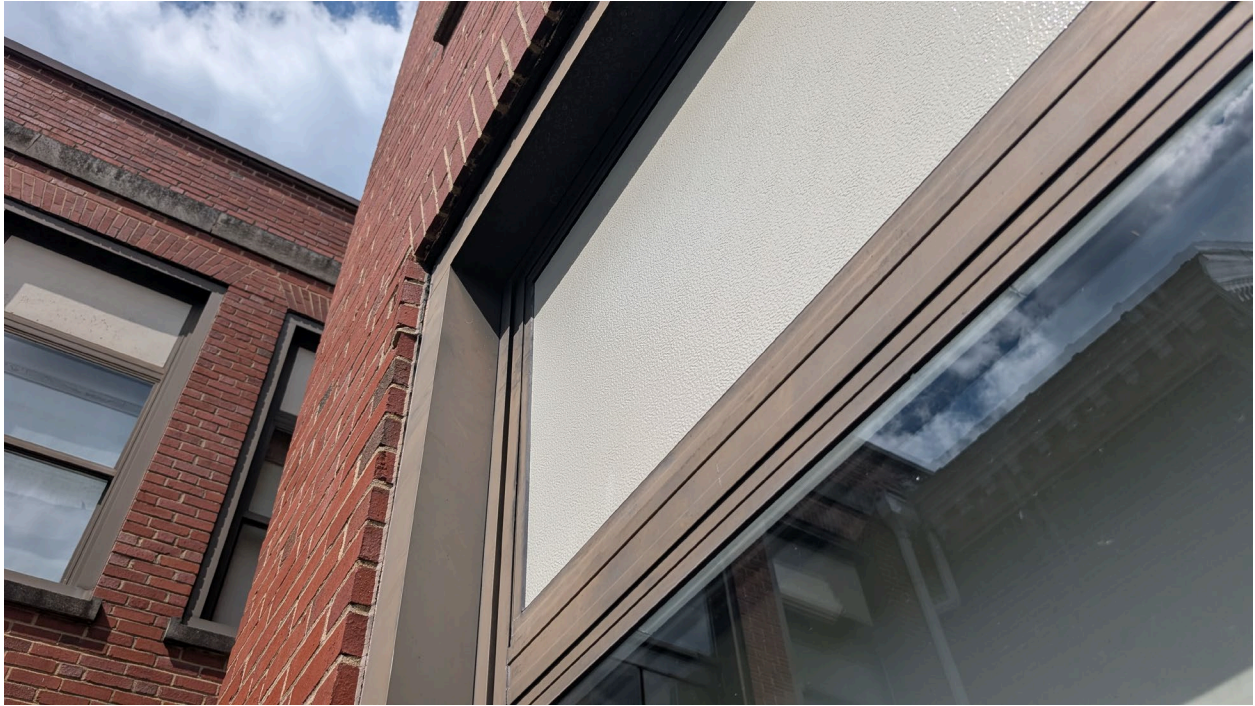
**NUMBER:** 038

South façade has noticeable outward displacement relative to window frame.

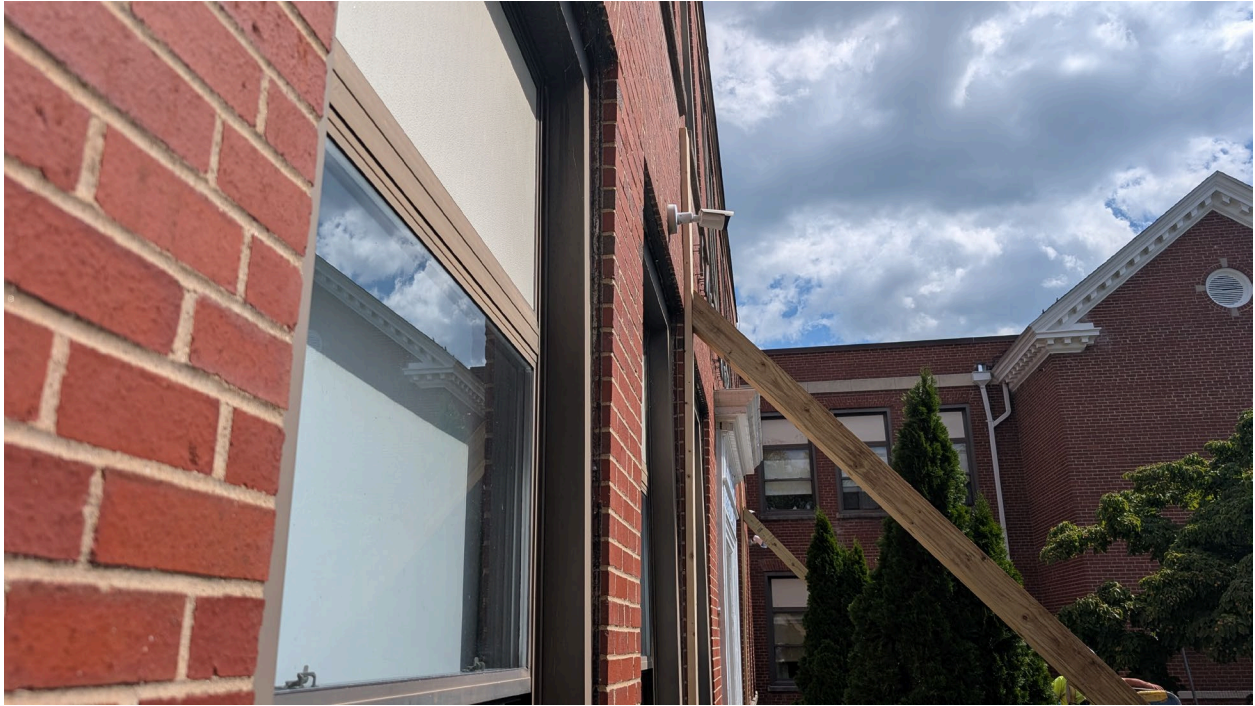
**NUMBER:** 039

South façade has noticeable outward displacement relative to window frame.

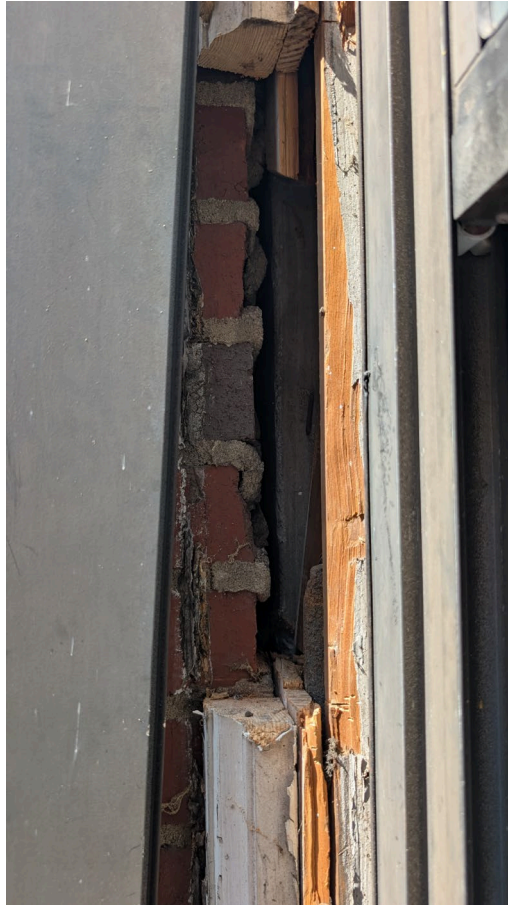
**NUMBER:** 040

South window frame removed to expose the concrete column supporting the second-floor framing and the cinder block load bearing wall supporting the roof structure.

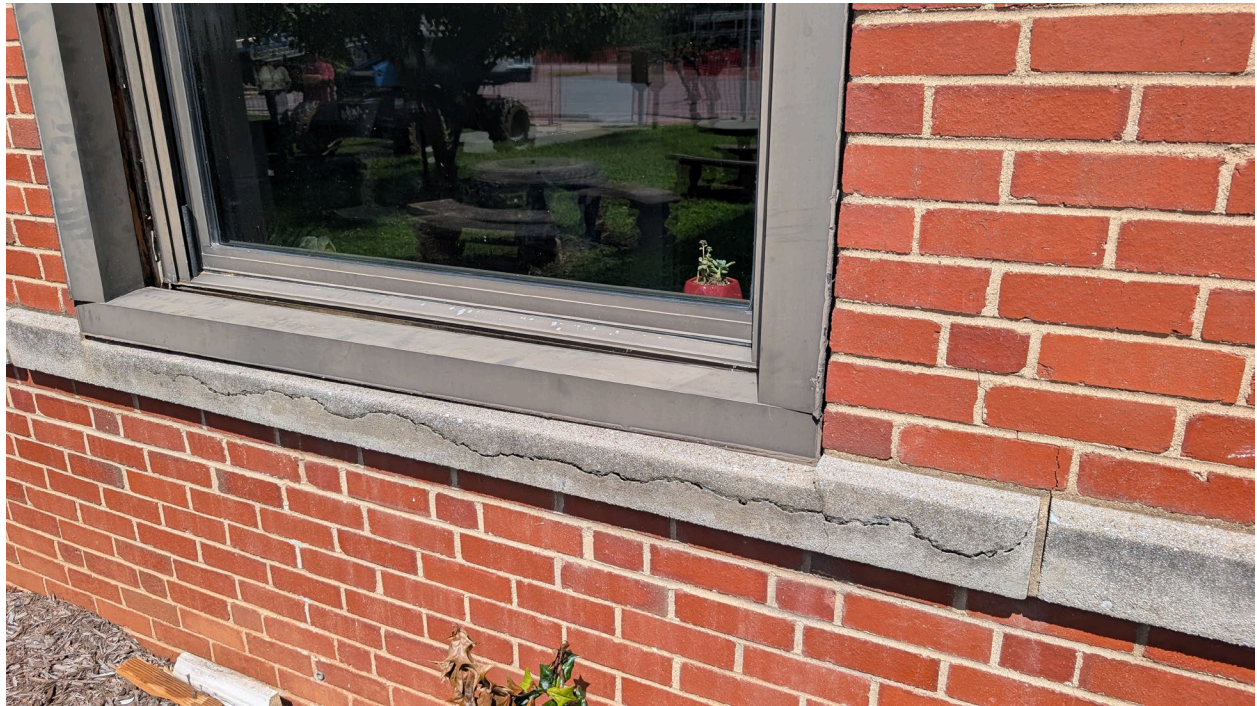
**NUMBER:** 041

South façade window frame. Horizontally cracked stone windowsill suggesting the infiltration of water into the cavity wall system.

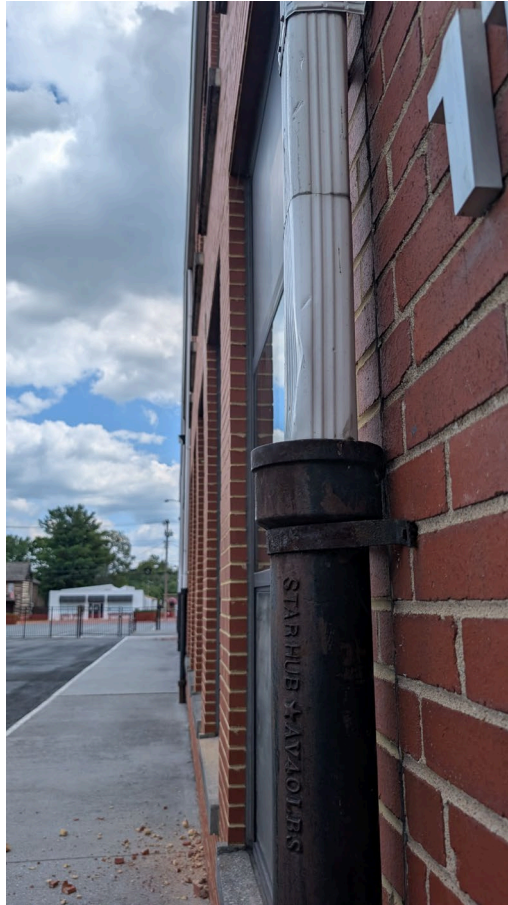
**NUMBER:** 042

West view of north wall façade. Minor movement of façade wall was observed.

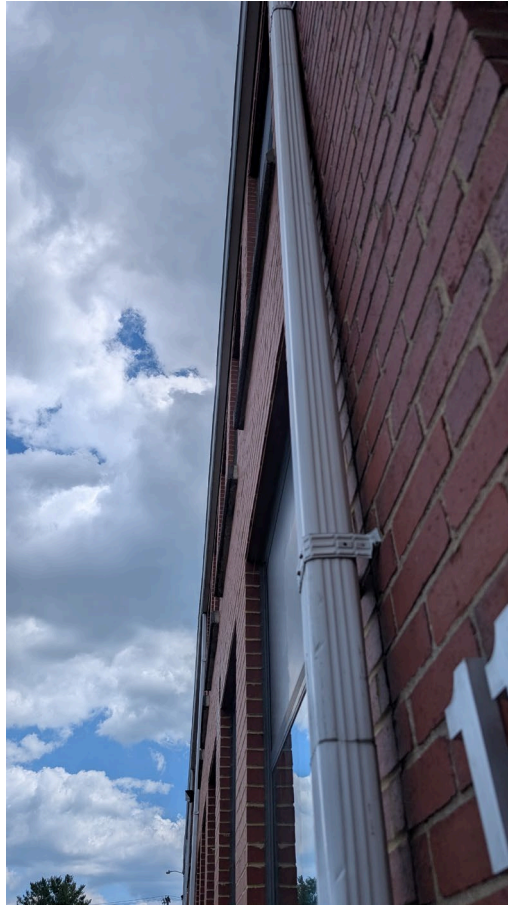
**NUMBER:** 043

West view of north wall façade. Minor movement of façade wall was observed.

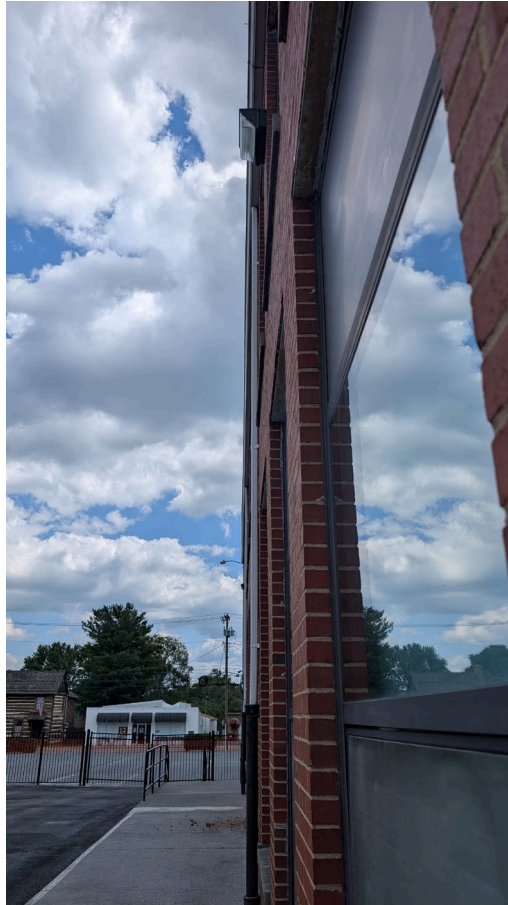
**NUMBER:** 044

West view of north wall façade. Minor movement of façade wall was observed.

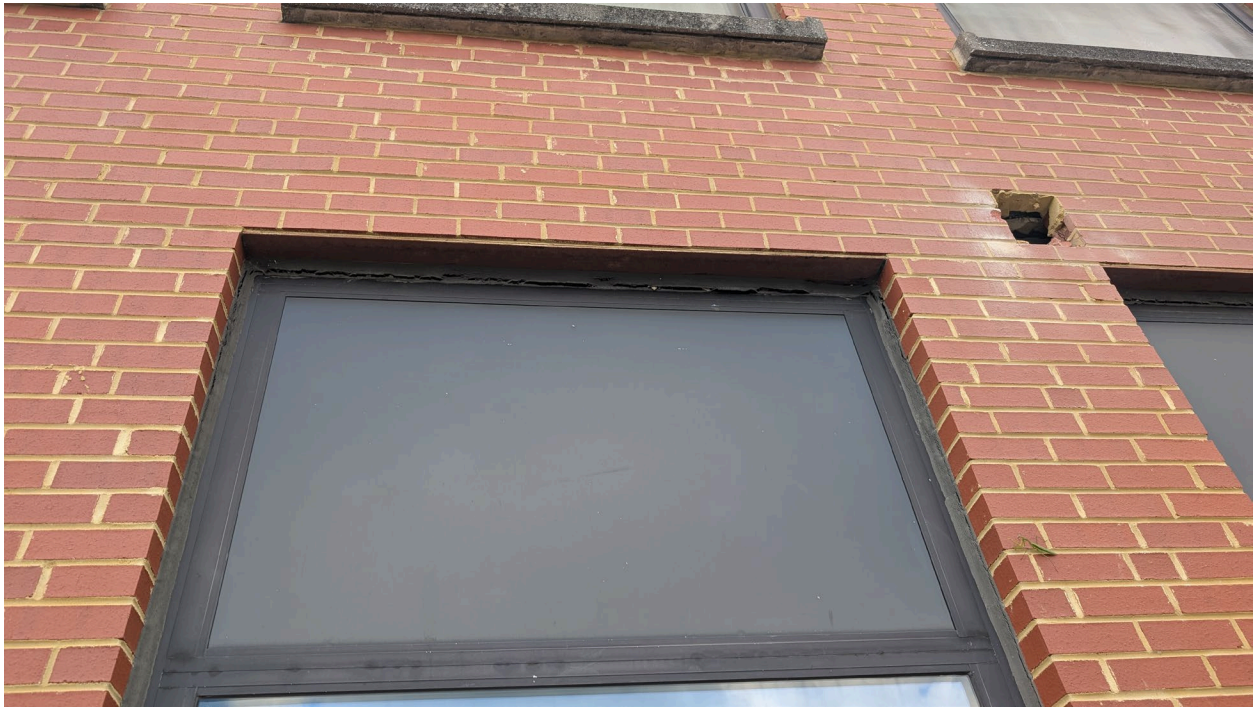
**NUMBER:** 045

Sealant distress/separation around windows indicating movement of the façade. Exploratory opening in wall provided by contractor.

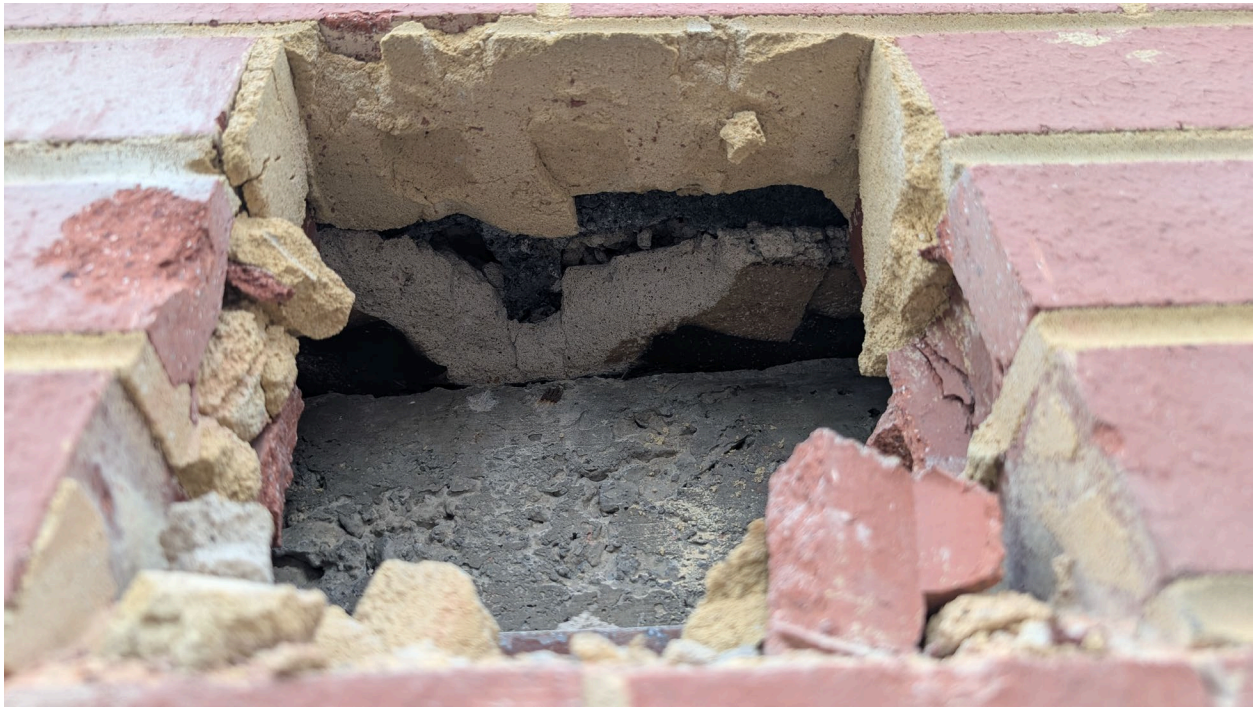
**NUMBER:** 046

Western façade wall portal opening. Closer view of **Photo 045** showing outward displacement of the cinder block load bearing wall and the cavity wall construction.

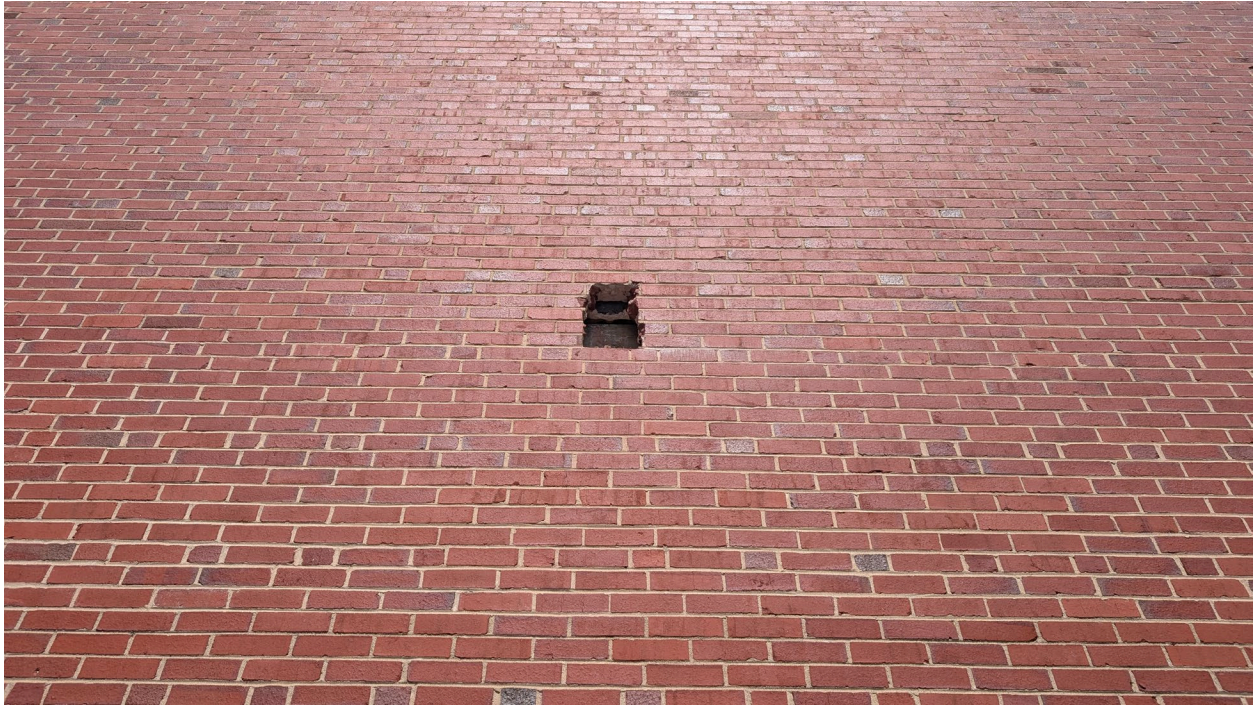
**NUMBER:** 047

Northern façade wall portal opening at west end. Similar cavity wall construction observed.

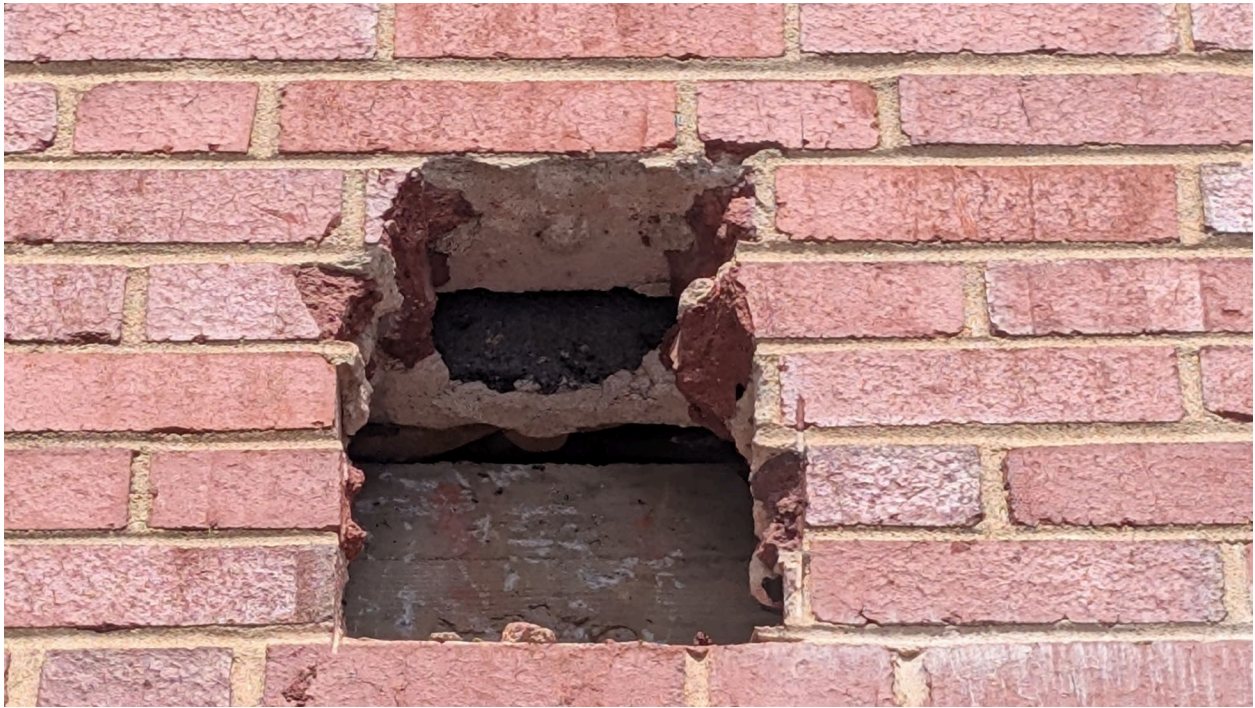
**NUMBER:** 048

Western façade wall portal opening. Closer view of **Photo 047** showing outward displacement of the cinder block load bearing wall and the cavity wall construction.

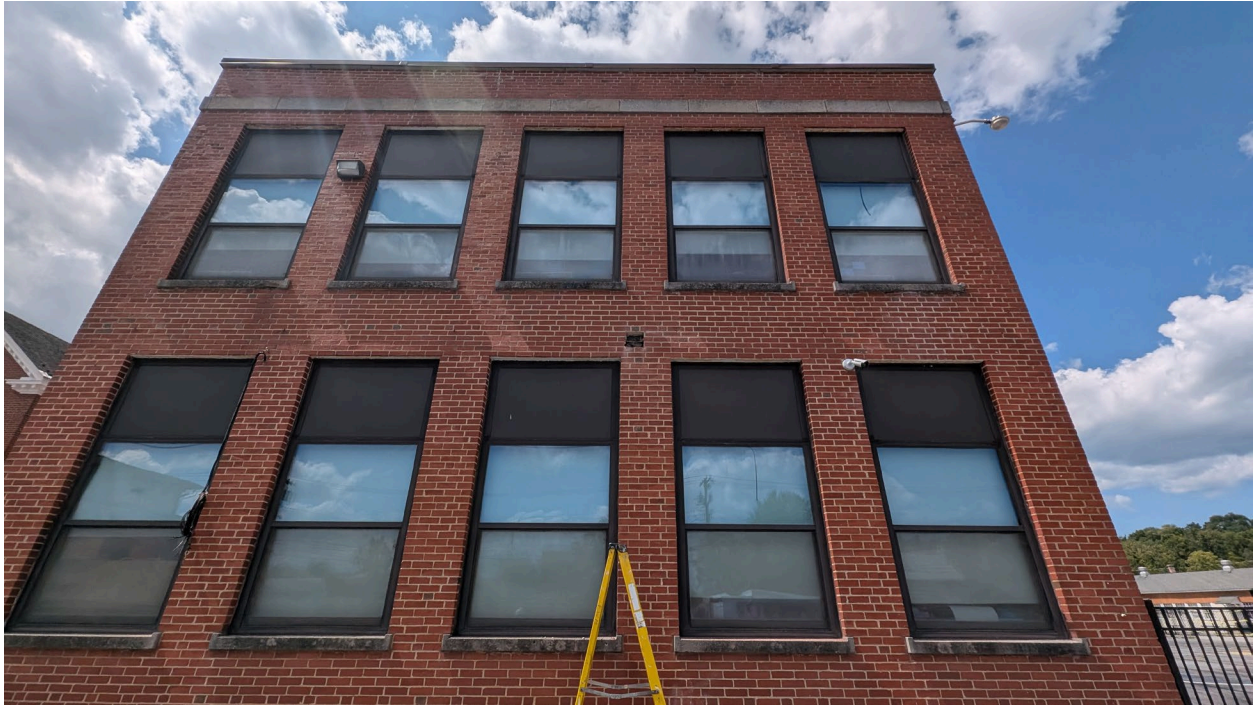
**NUMBER:** 049

**COMMENTS:**  
Eastern façade wall overall view.

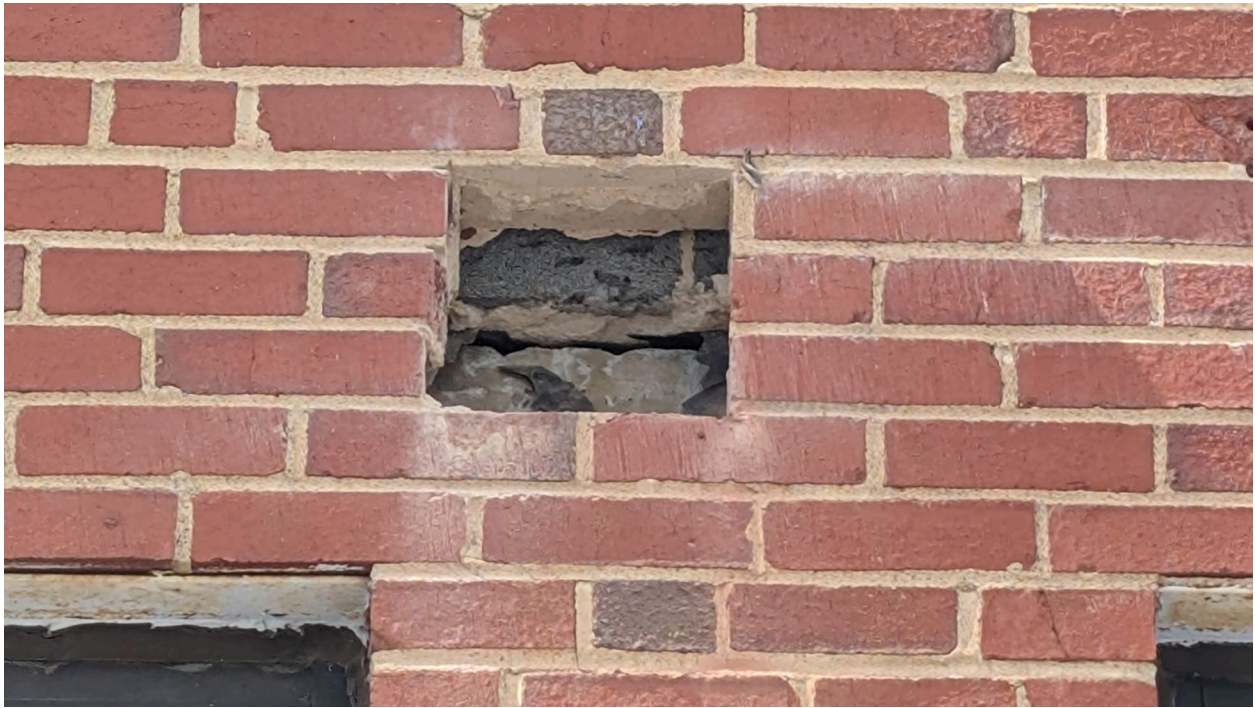
**NUMBER:** 050

Eastern façade wall portal opening. Closer view of **Photo 049** showing outward displacement of the cinder block load bearing wall and the cavity wall construction.

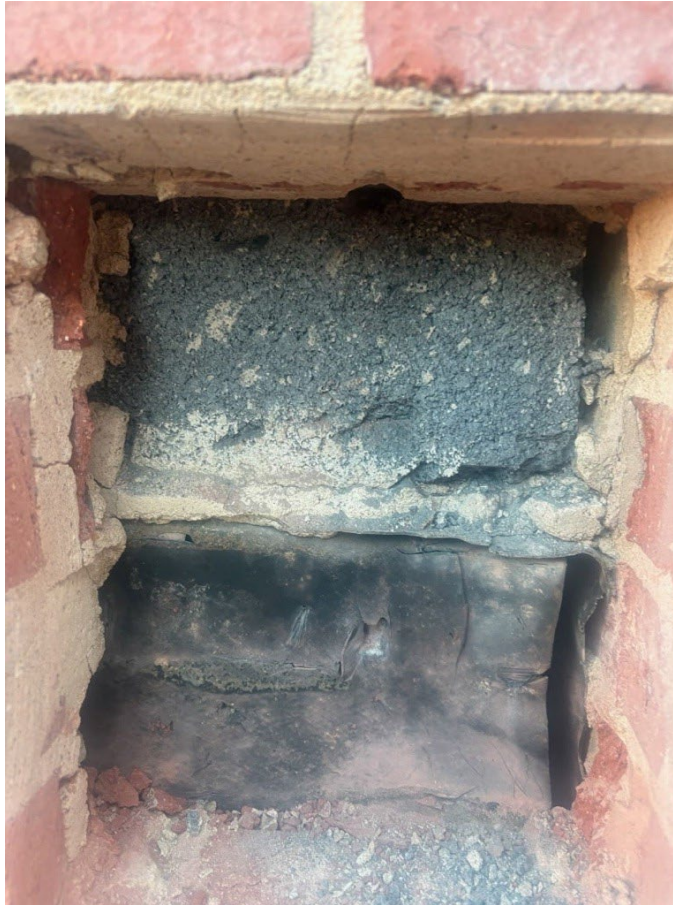
**NUMBER:** 051

Additional wall opening was created by the contractor on August 25, 2026 near the corner of the southern façade. Note the cinder block load bearing wall is essentially flush with the edge of the second-floor concrete slab.

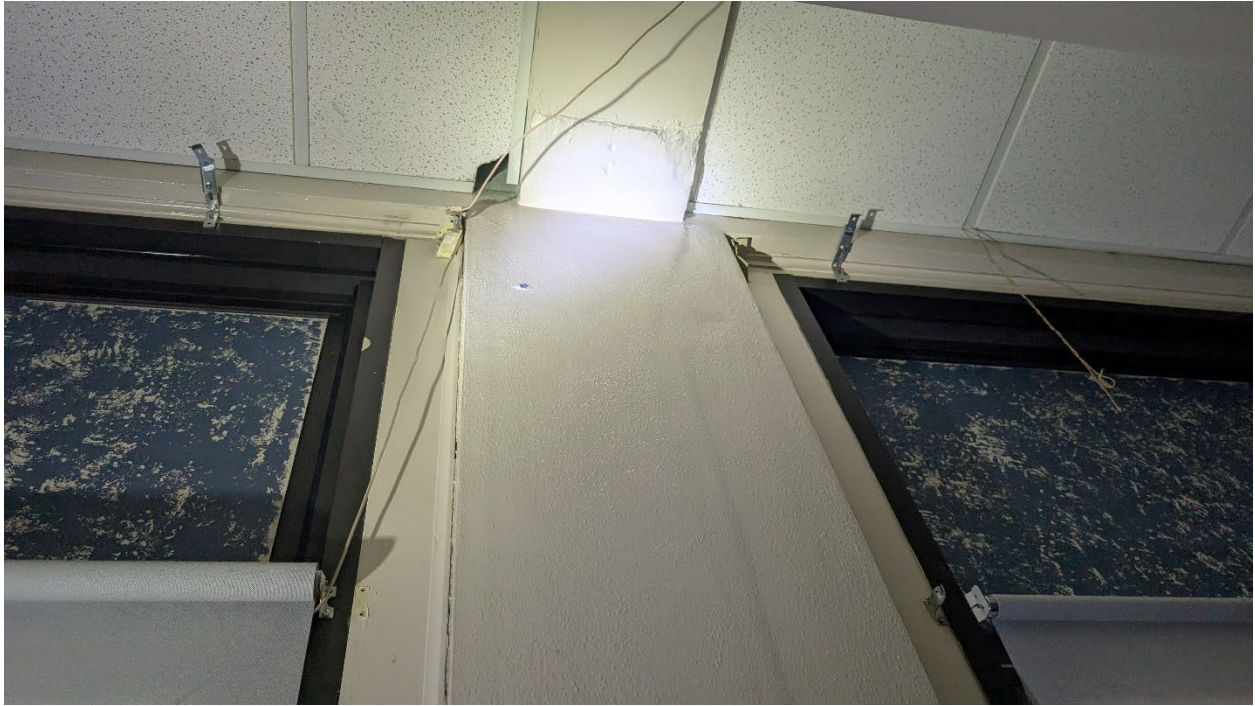
**NUMBER:** 052

Existing concrete frame column and beam viewed from interior. No structural distresses observed.

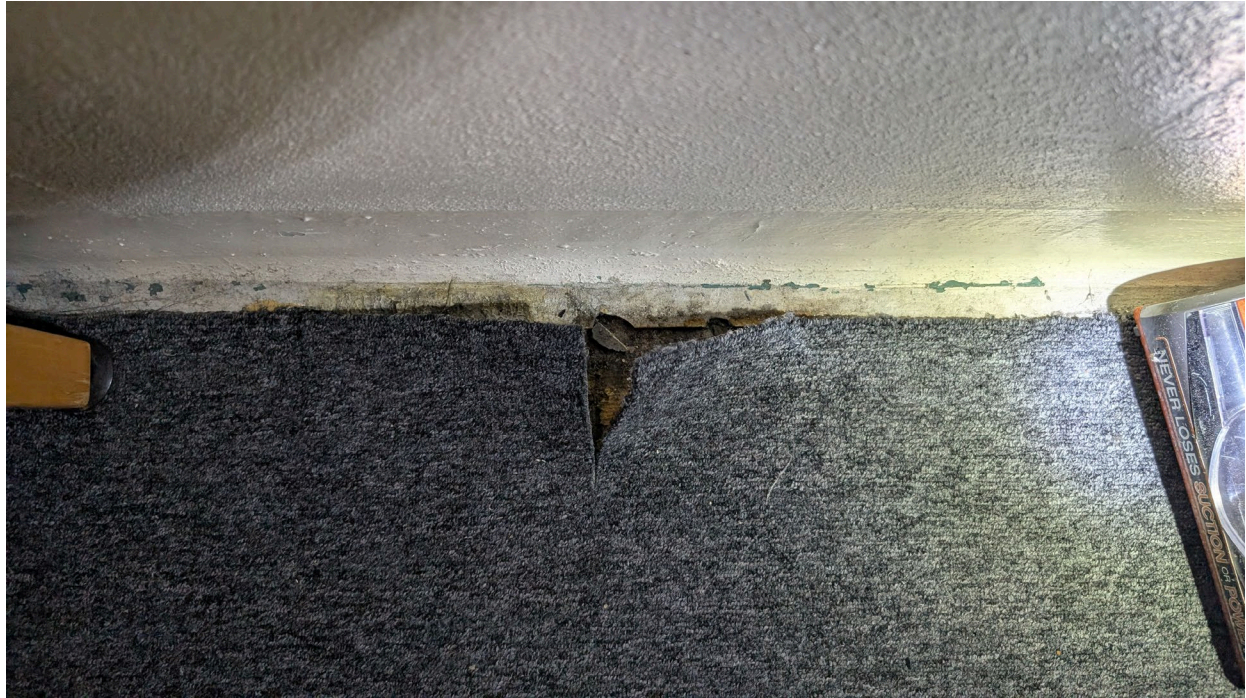
**NUMBER:** 053

Second-floor area in library below carpet. Possible movement of cinder block wall evident based on exposed unfinished slab below carpet.

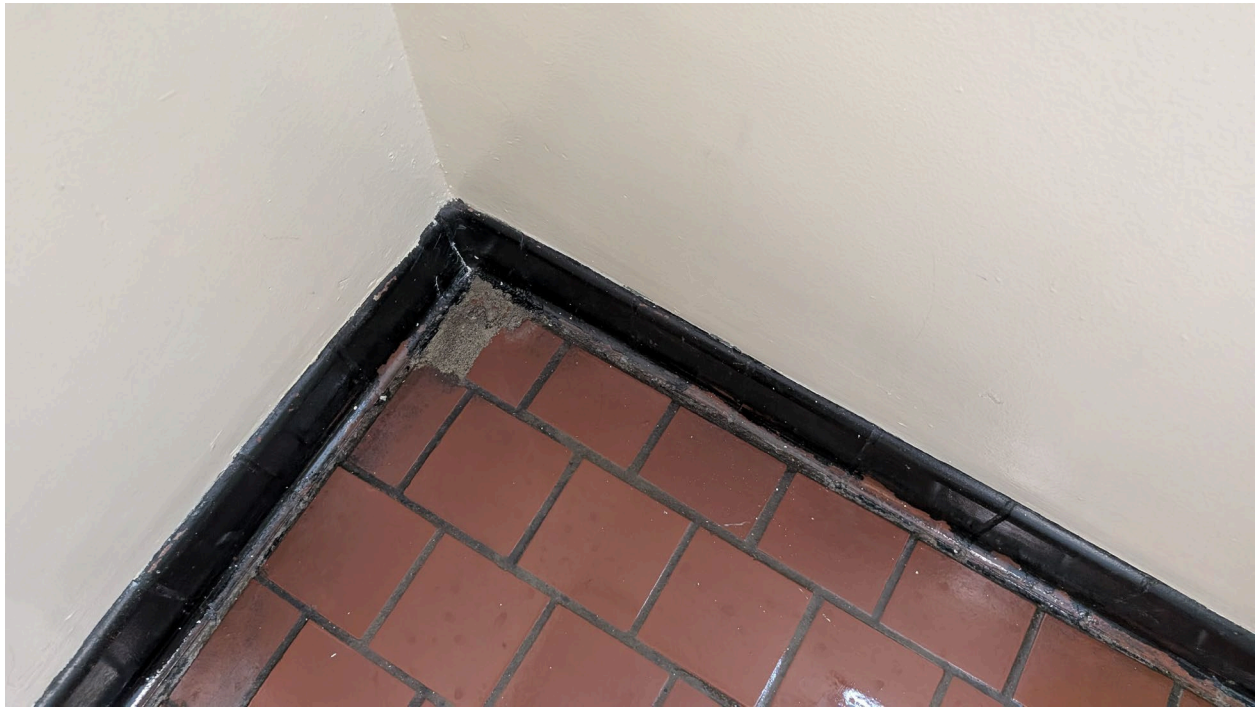
**NUMBER:** 054

Second floor bathroom at far southwest corner along the south façade. No evidence of horizontal displacement as suspected by **Photo 051**.

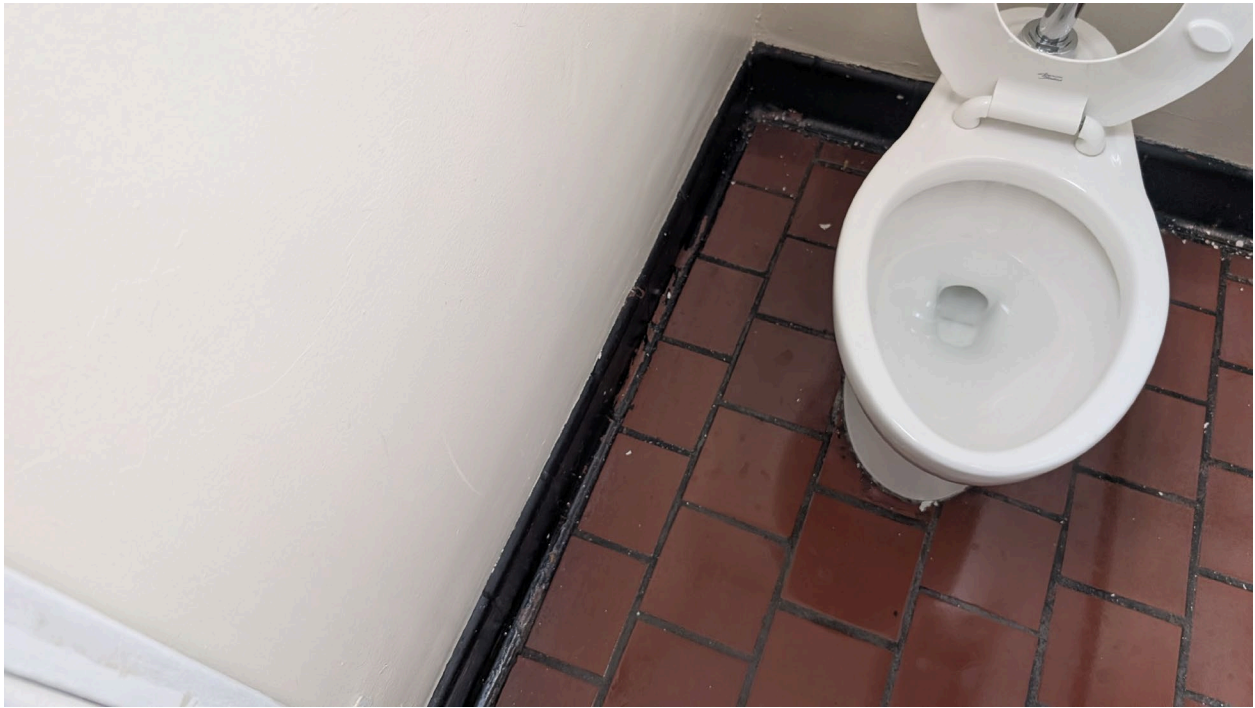
**NUMBER:** 055

Second floor bathroom at far southwest corner along the south façade. No evidence of horizontal displacement as suspected by **Photo 051**.

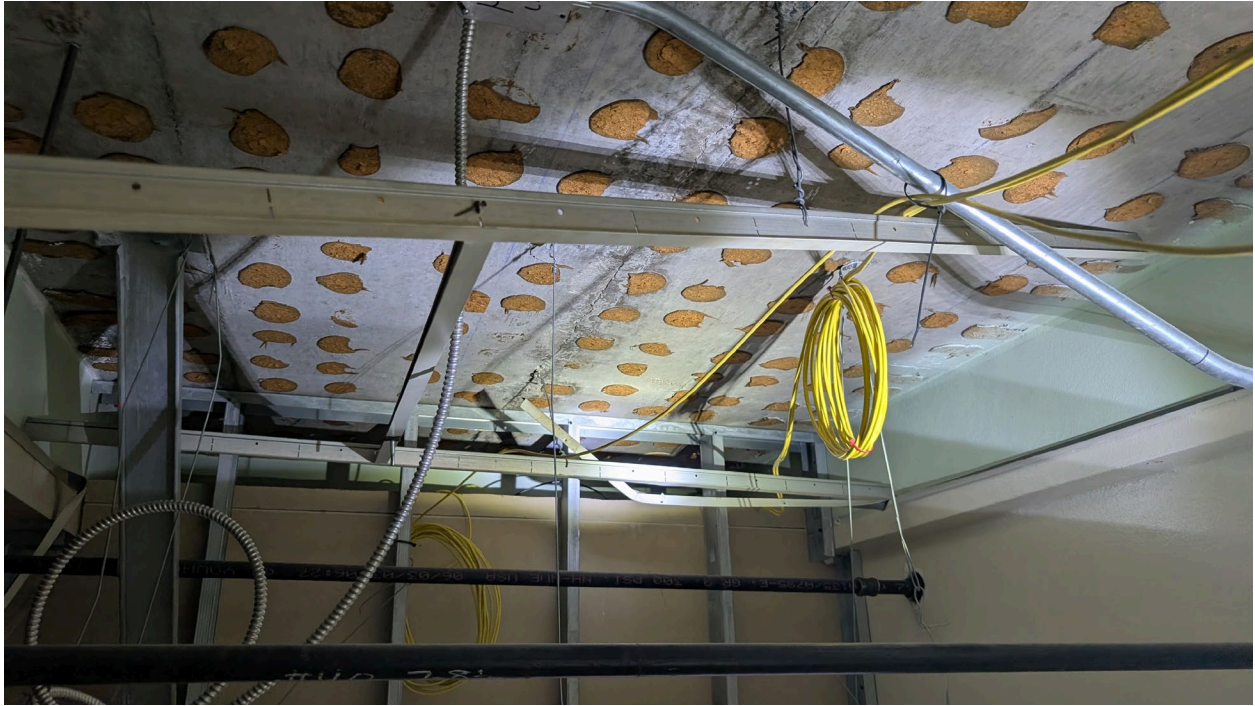
**NUMBER:** 056

First floor ceiling cavity space showing concrete beam and slab construction of the second-floor framing.

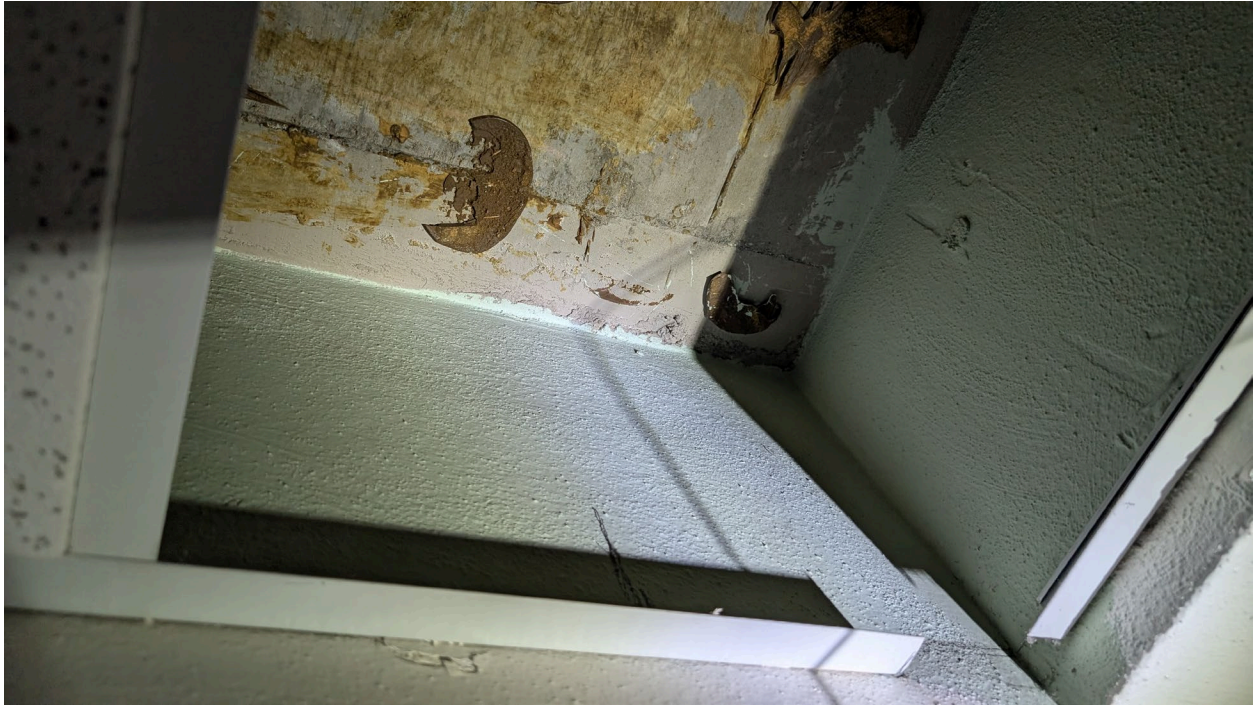
**NUMBER:** 057

First floor ceiling cavity space showing concrete beam and slab construction of the second-floor framing.

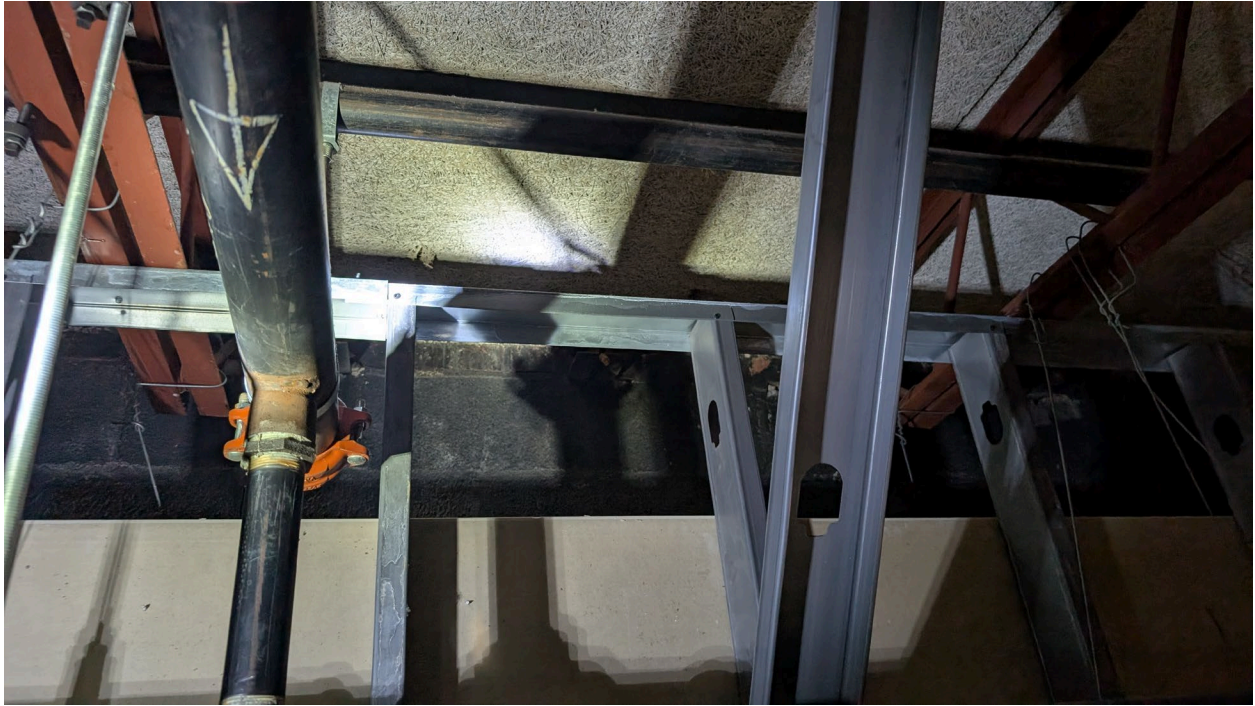
**NUMBER:** 058

Roof framing above second floor library reflecting newer joist construction with bulb tee tectum roof decking system.

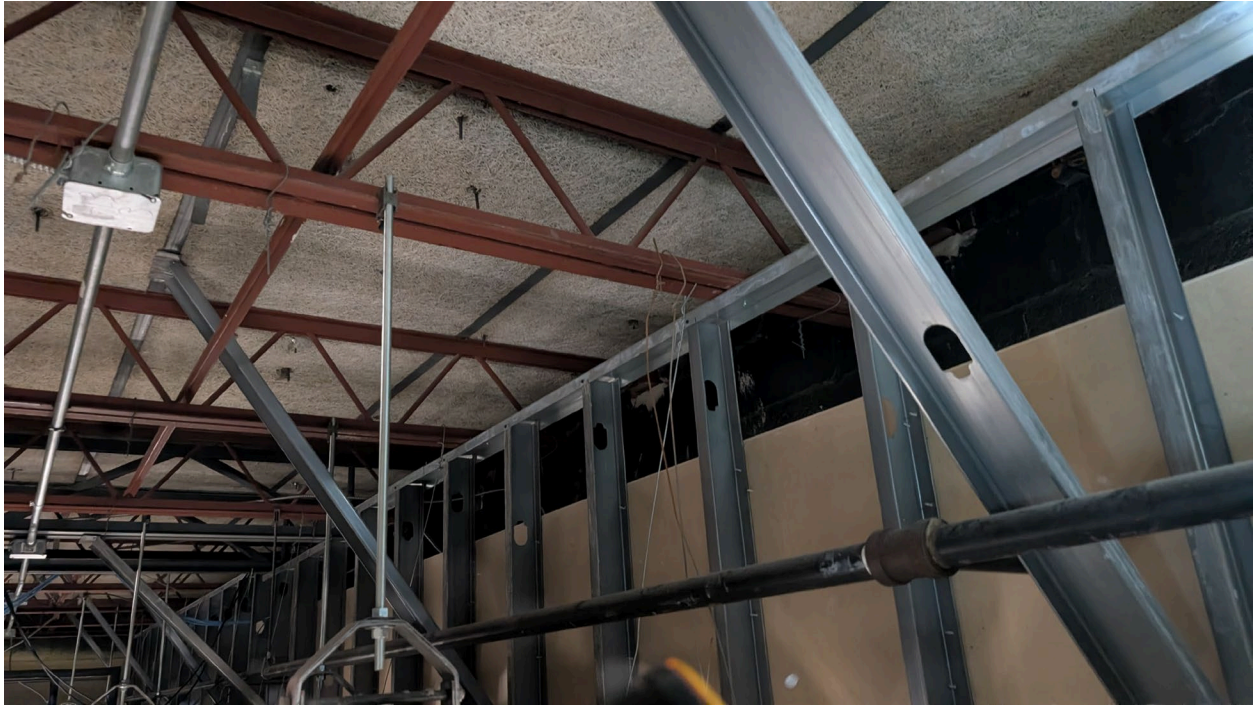
**NUMBER:** 059

Roof framing above second floor library reflecting newer joist construction with bulb tee tectum roof decking system.

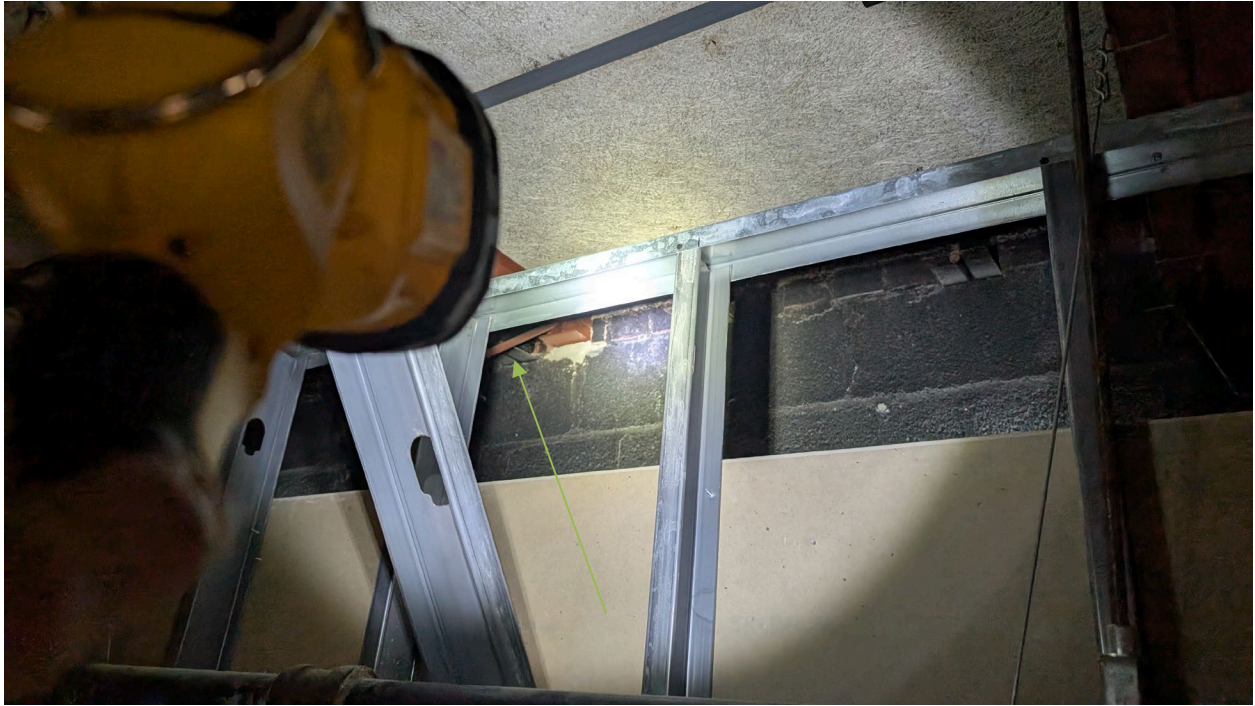
**NUMBER:** 060

Roof framing above second floor library reflecting newer joist construction with bulb tee tectum roof decking system.  
Note: green arrow pointing to old joist seat remaining from original roof construction.

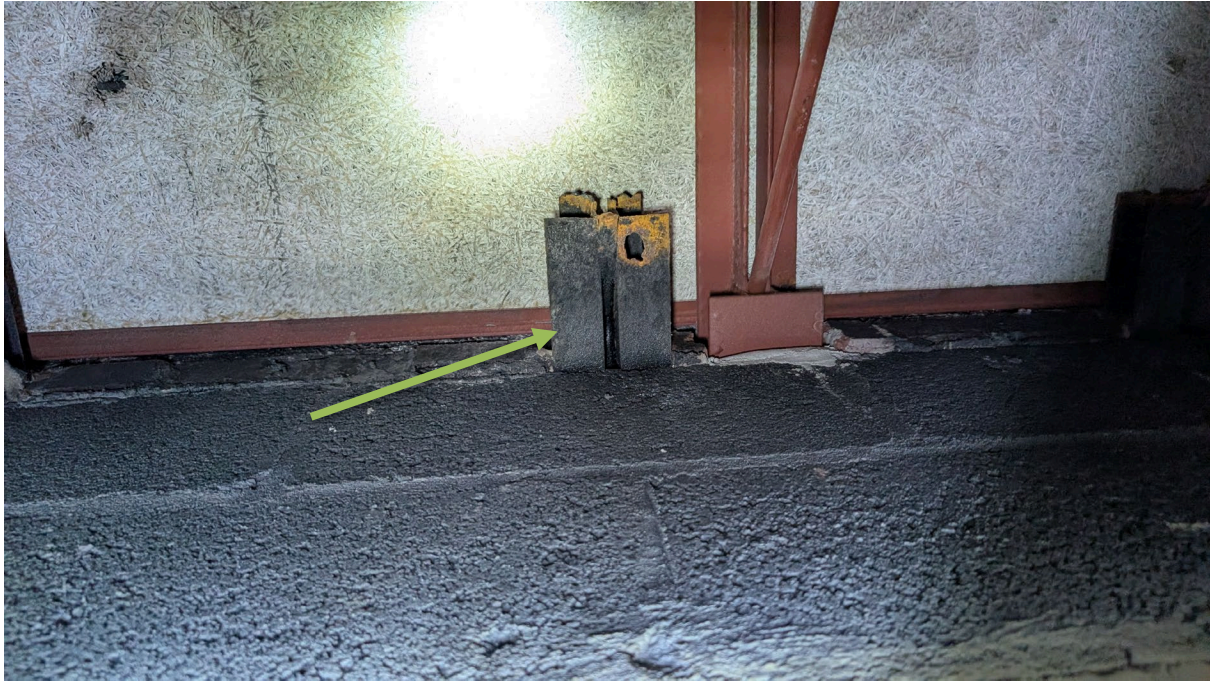
**NUMBER:** 061

Roof framing above second floor library reflecting newer joist construction with bulb tee tectum roof decking system.  
Note: green arrow pointing to old joist seat remaining from original roof construction.

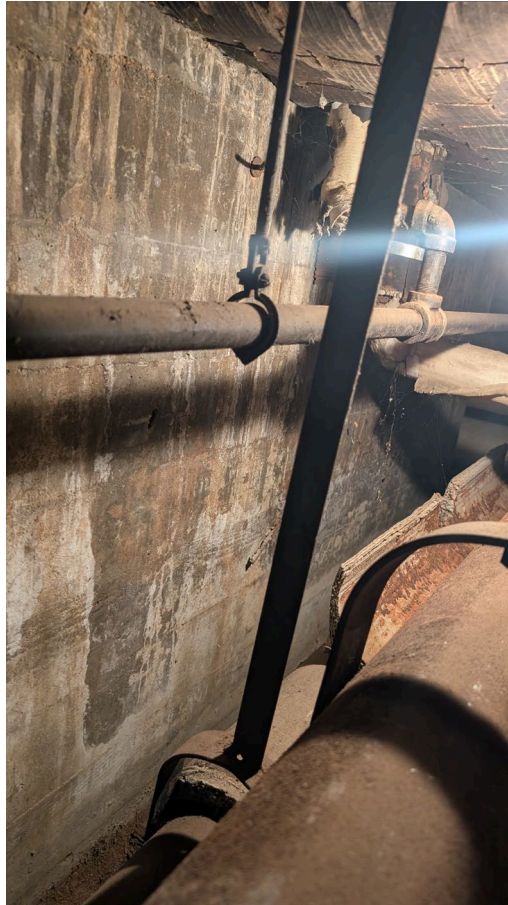
**NUMBER:** 062

Shallow crawlspace along exterior south façade wall showing cast-in-place concrete foundation wall with no visible distress or displacement.

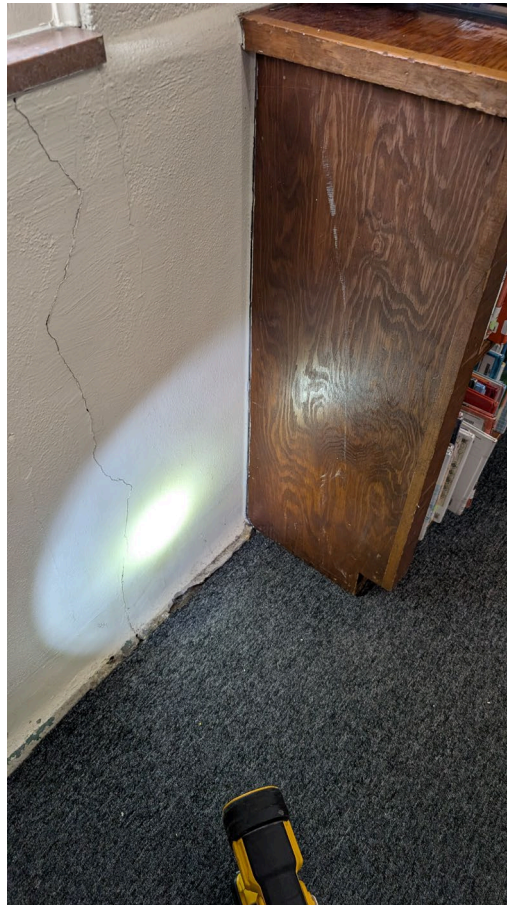
**NUMBER:** 063

Second-floor area in library below carpet. Possible movement of cinder block wall evident based on exposed unfinished slab below carpet. Also, visible separation of vertical sealant along wall and casework.

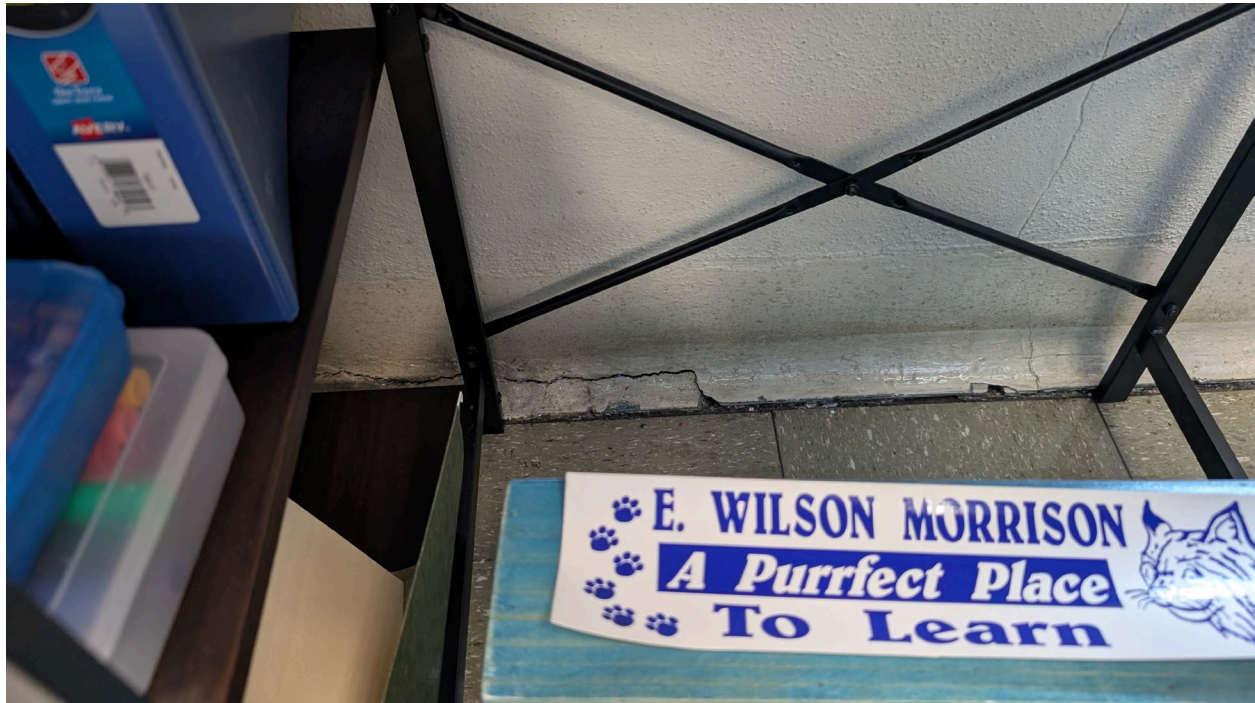
**NUMBER:** 064

Second floor of storage closet adjacent to library. Separation/cracking present between floor base and wall.
