**LOCATION:** E. Wilson Morrison Elementary School

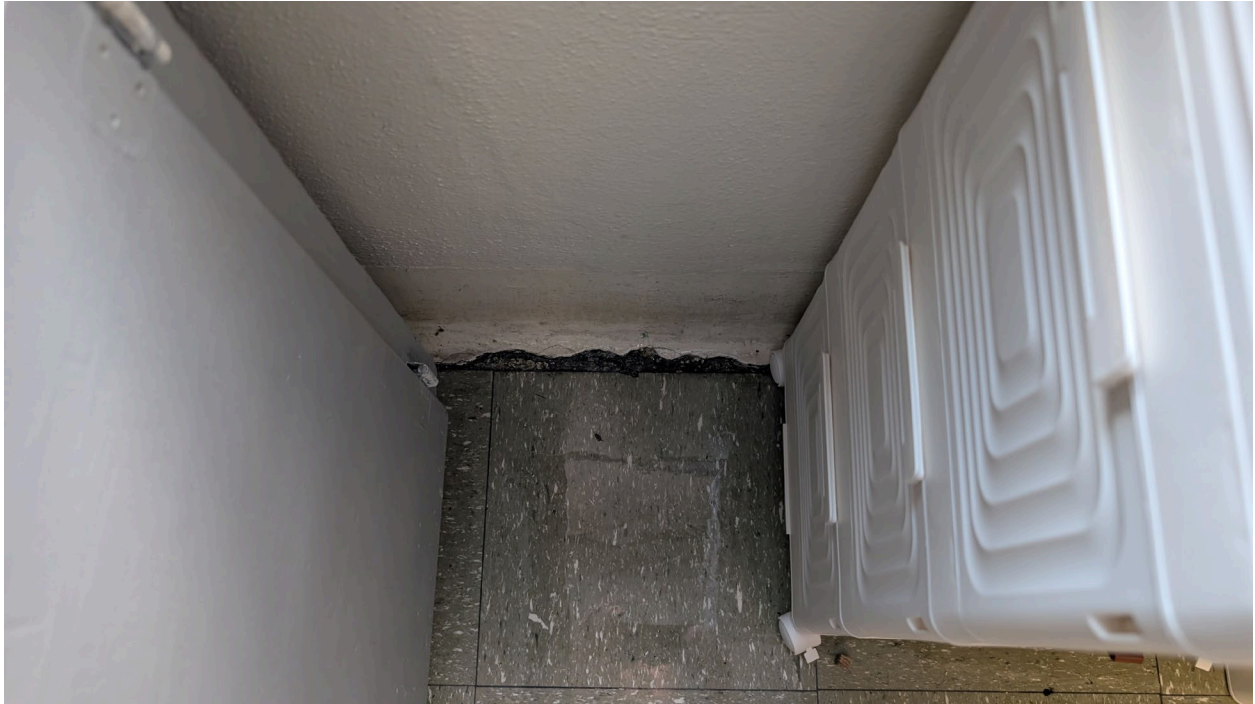
**NUMBER:** 065

Second floor of storage closet adjacent to library. Separation/cracking present between floor base and wall.
