KLUBER PROJECT NO. 26-508-1715

# E. Wilson Morrison Elementary School

**Structural Façade Assessment**  
**40 Crescent Street**  
**Front Royal, Virginia 22630**

■ August 31, 2026

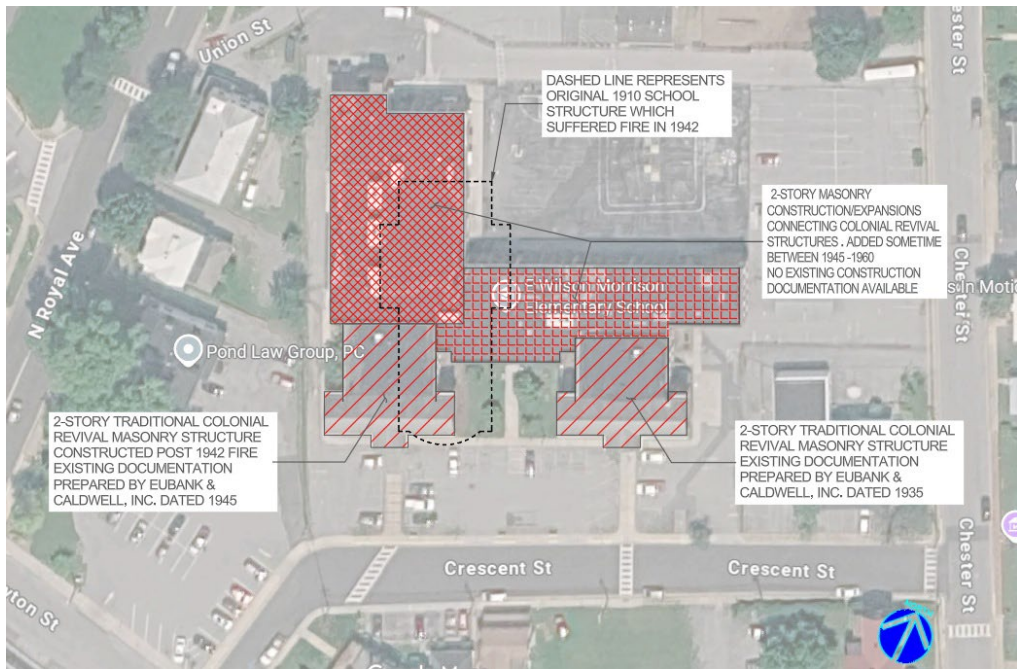
**Figure No. 001**  
**Site Plan Construction History**

The original school building constructed on Crescent Street was erected in 1910. In 1935, the school underwent re-building and expansions which included the 2-story masonry traditional colonial revival structure on the east end of the site and a gymnasium. Around 1942, the original 1910 school suffered a fire which led to its demolition. In 1945, a second 2-story colonial revival structure was constructed on the west end of the site which mimicked the construction of the original 1935 building. Sometime between 1945 and 1960, additional 2-story masonry additions were added to connect the two revival buildings, refer to **Figure No. 001**.

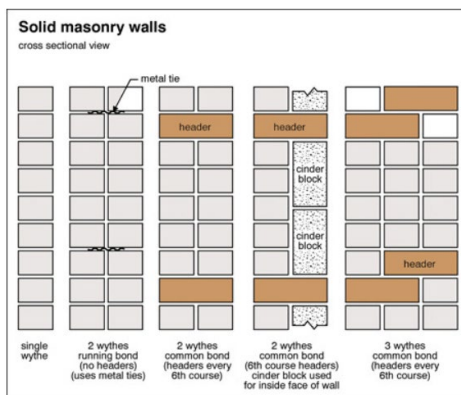
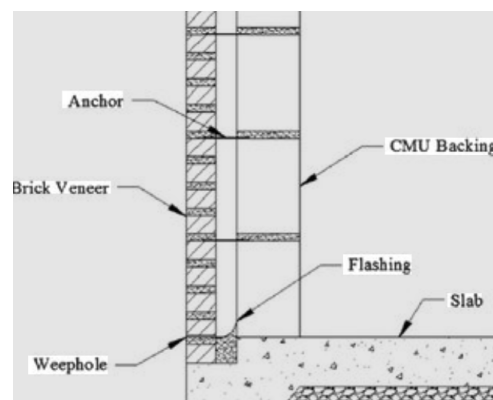
**Figure No. 002**  
**Mass Masonry Wall Construction Versus Cavity Wall Construction**

*Original 1935 and 1950 buildings appear to utilize this façade layout, but with a “mass-wall” construction type as shown in **Figure No. 002** - 3 wythe construction. The post 1945 construction replicates this design architecturally as seen above. Rather than the header courses tying directly into the masonry construction beyond with a full unit turned 90 degrees, these units have been cut, and metal ties have been provided for lateral stability to the cinder block construction beyond, typical for cavity wall construction.*

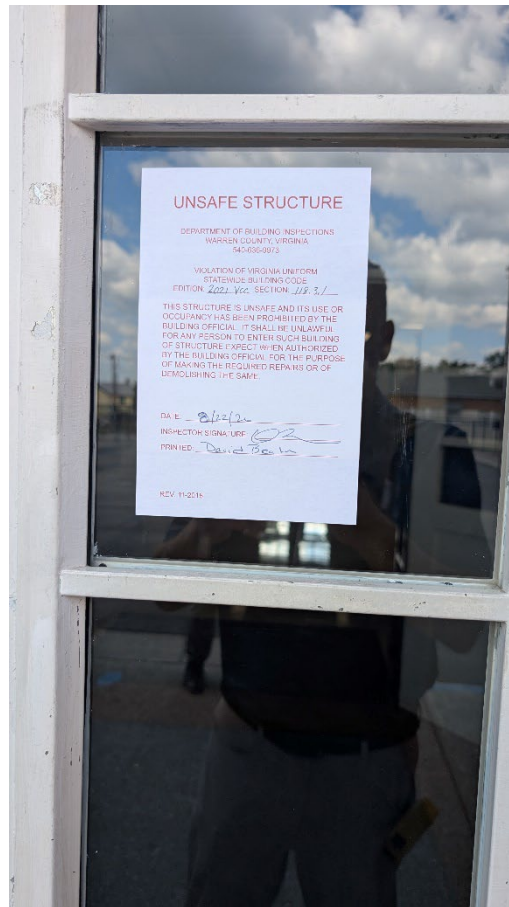
Department of Buildings unsafe structure notice, issued August 22, 2026.
